# AIRCRAFT ACCIDENT REPORT AND EXECUTIVE SUMMARY

| | | | | Reference: | CA18/2/3/8309 | |

## AIRCRAFT ACCIDENT REPORT

**Name of Owner/Operator** : Wilhelm Daniel Calitz  
**Manufacturer** : PAP  
**Model** : 1400 R125  
**Nationality** : South African  
**Registration Marks** : Not applicable  
**Place** : Island View close to Alexandria  
**Date** : 30 May 2007  
**Time** : +/-1534Z

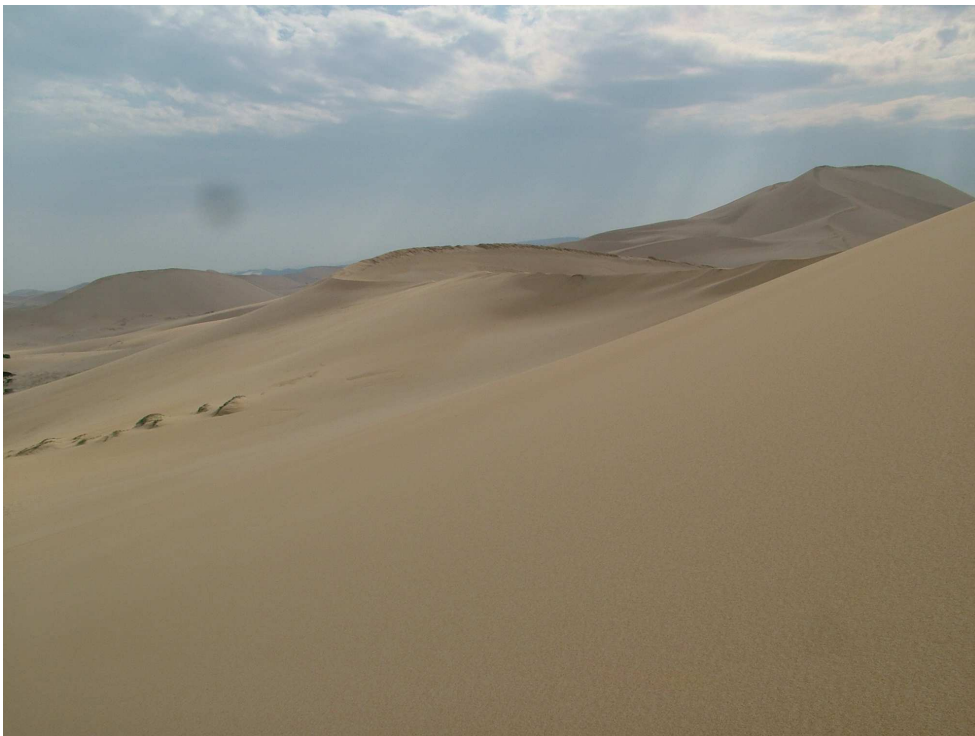
**Figure 4:** The sand dunes over which the pilot flew prior to the accident.

1.12.2 Information downloaded from the Garmin Foretrex 201 Global Positioning System revealed that the pilot had been flying along the coast at a height of approximately 158 metres above ground level over sand dunes when he suddenly lost altitude and impacted with the ground.

- 4.1 Powered paraglider pilots should increase the height at which they fly over sand dunes or mountains due to the possible risk of rotor steaming.
- 4.2 Powered paraglider pilots who wish to fly on extended trips should take more precautions and perform better flight planning when flying in unknown territory. They should also plan their trip to land at specific and identified places.

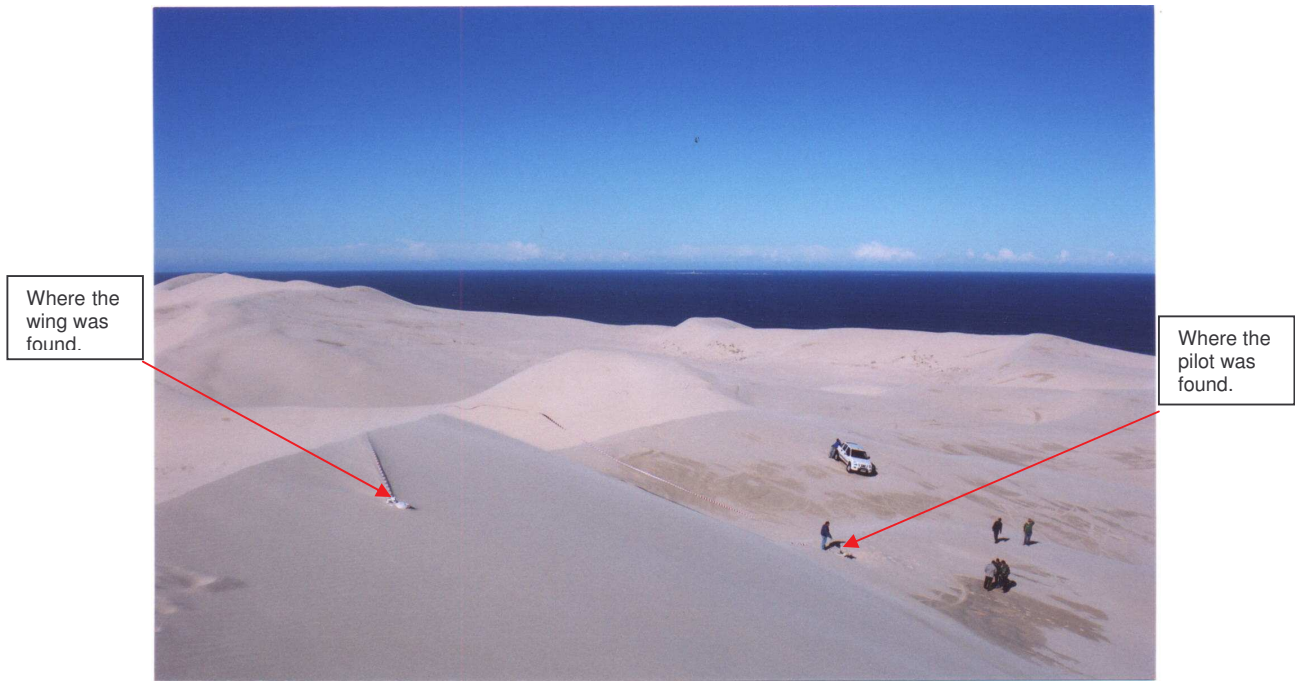
**Figure 5:** The position of the wing in relation to where the pilot was found.

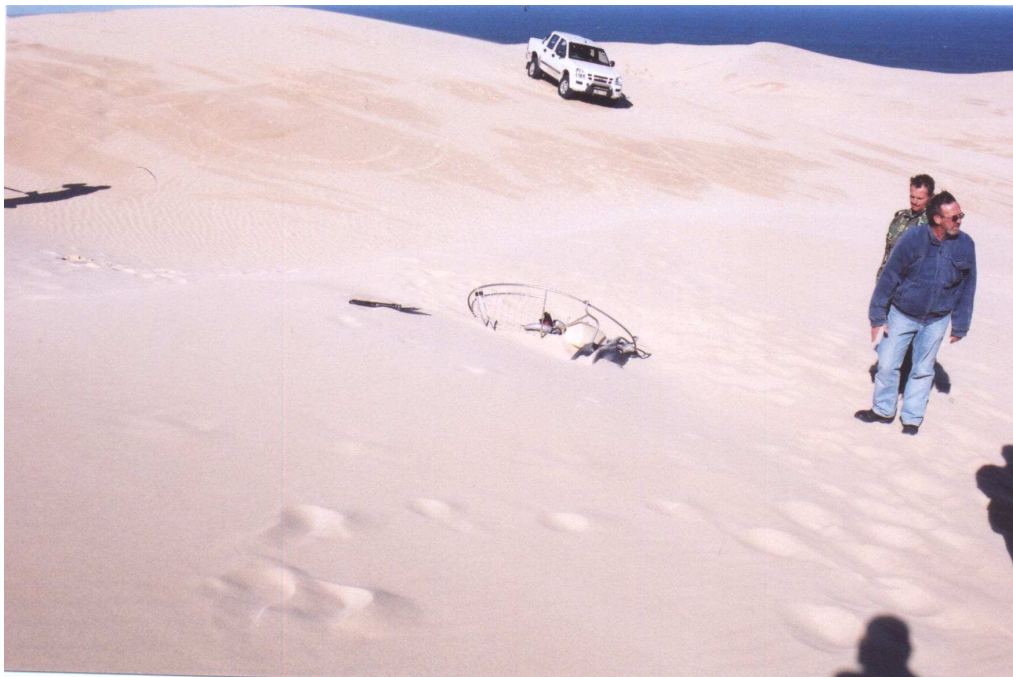
**Figure 6:** Where the wreckage and pilot were found buried under sand.

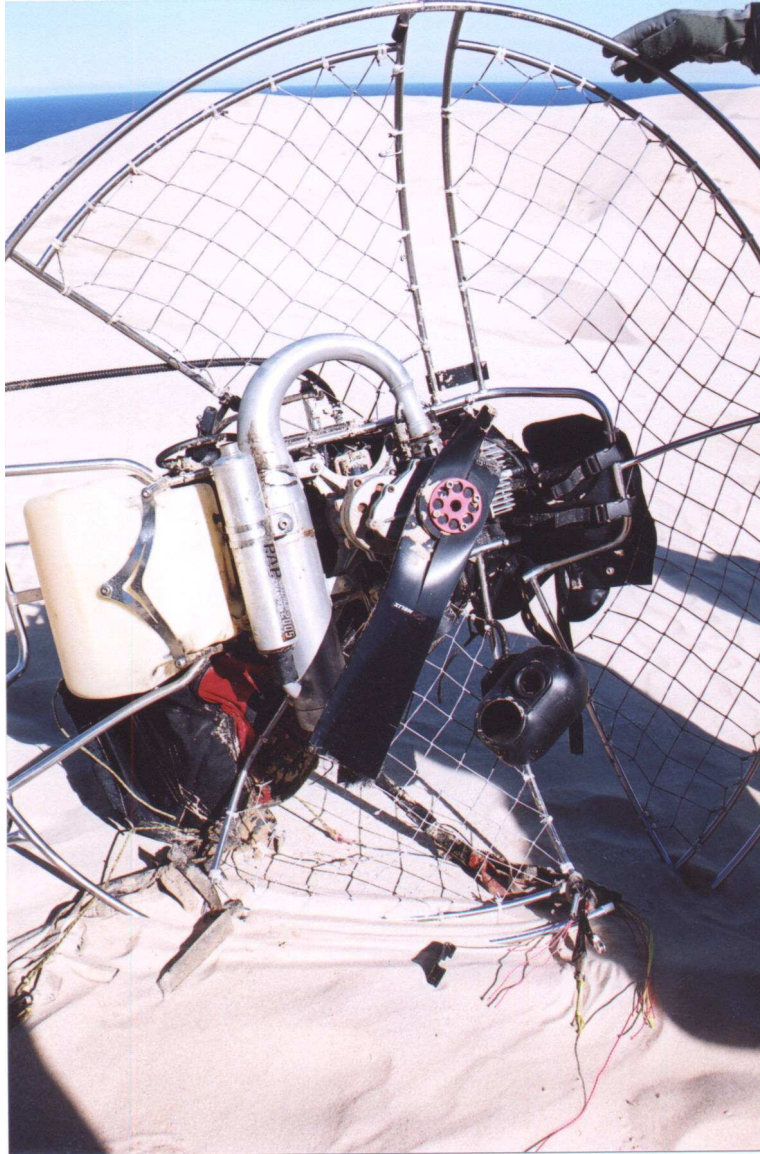
1.12.2 An on-site investigation revealed that the powered paraglider's frame was bent in several places, and the engine mountings and propeller were broken. This damage had been sustained as a result of impact with the ground.

**Figure 7:** The damage sustained on impact with the ground.

- 3.1.1 The pilot was correctly licensed at the time of the accident.
- 3.1.2 The powered paraglider sustained damage to the frame of the engine, propeller and engine mountings on impact with the terrain.
- 3.1.3 Ripping and burning effects were found on the wing surface, as well as a line-over on the left-hand side of the wing.
- 3.1.4 The pilot was wearing a full-face helmet at the time of the accident.

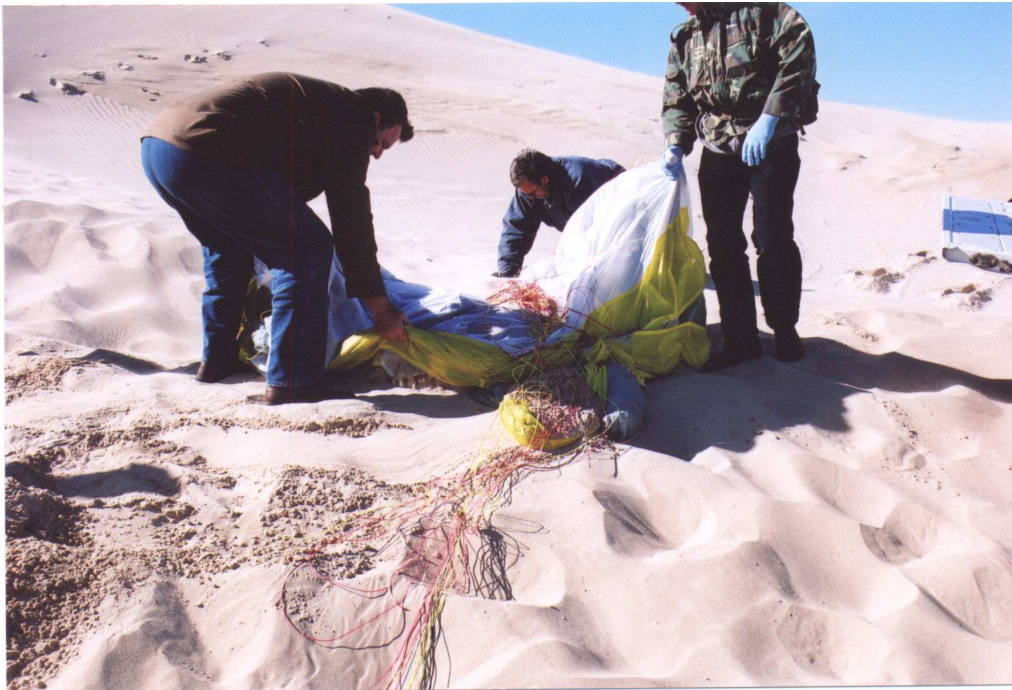
1.12.3 Further investigation revealed that the wing had a line over it and the wing surface displayed burn marks due to friction.

**Figure 8:** The condition of the wing when it was found.

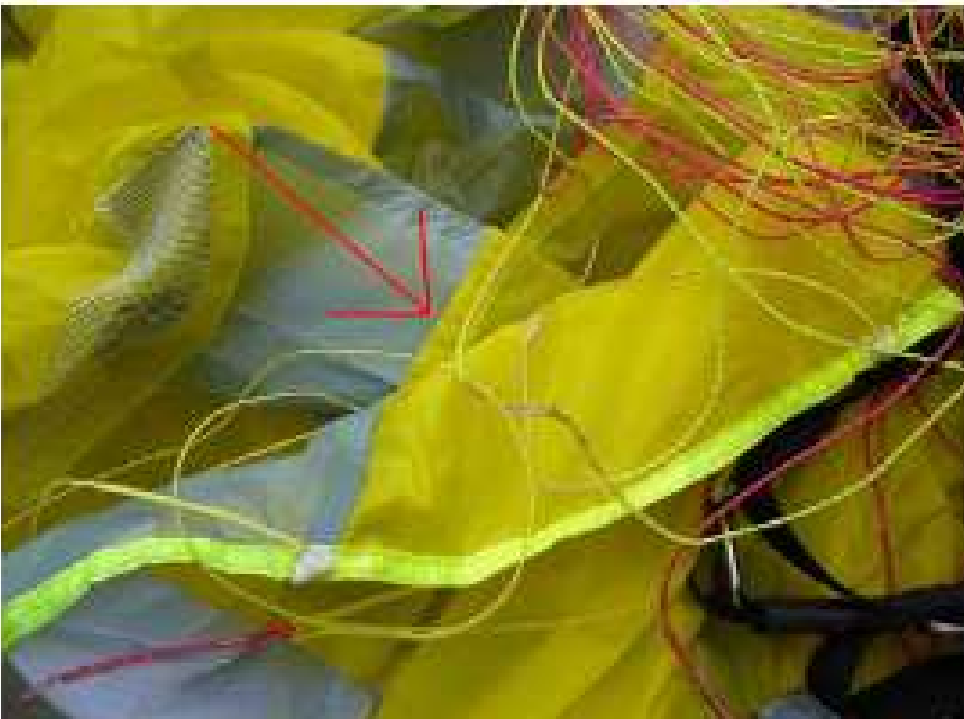
**Figure 9:** The ripping and burning effect on the wing surface.

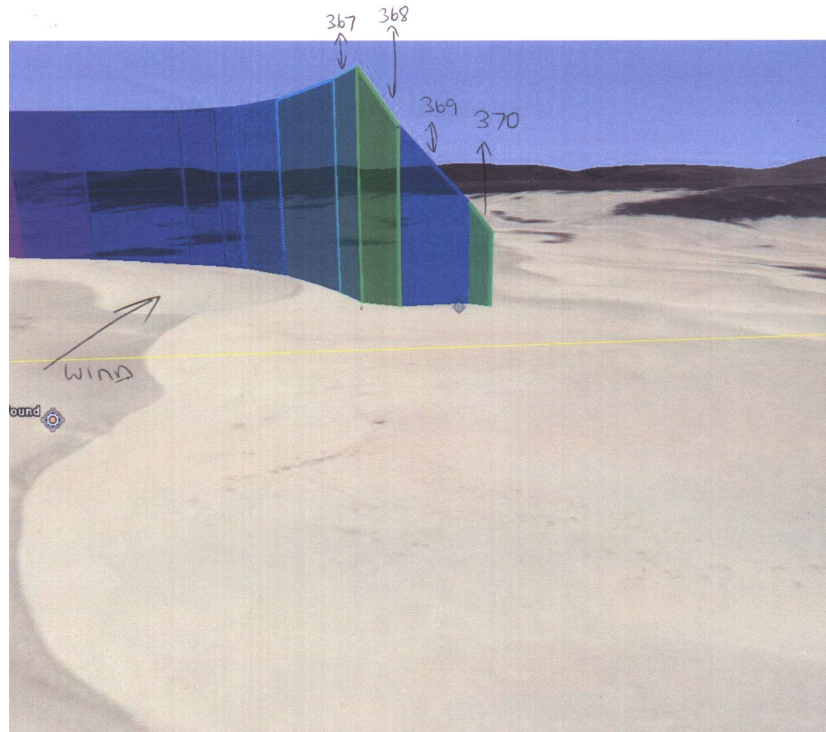
1.16.2 The pilot took off at 1452Z and flew east from the Sundays River mouth towards Cannon Rocks. At 1534Z, his speed decreased by 22 km/h within 4 seconds of the GPS log but no altitude was lost. At 1534Z, his track direction changed dramatically.

In five seconds there was a reduction of 36 m in altitude. Speed increased by 31 km/h. At 1534Z, track direction changed dramatically, indicating a full 360° rotation. Groundspeed reduced by 22 km/h and altitude reduced by another 45 m.

**Figure 10:** GPS download indicating the track and height the pilot flew.

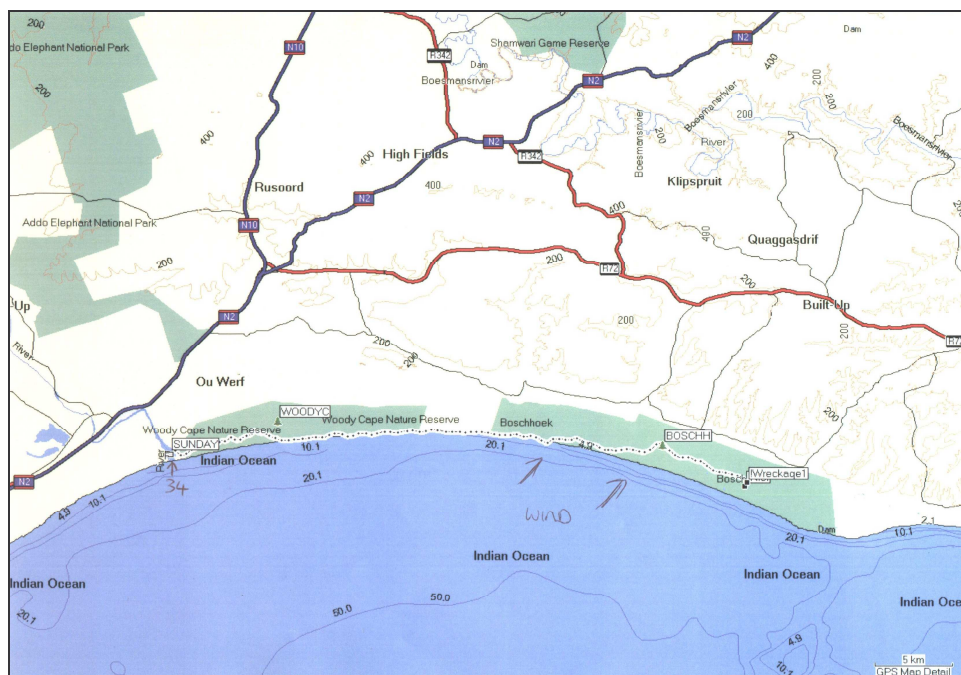
**Figure 11:** GPS download indicating the track the pilot flew.

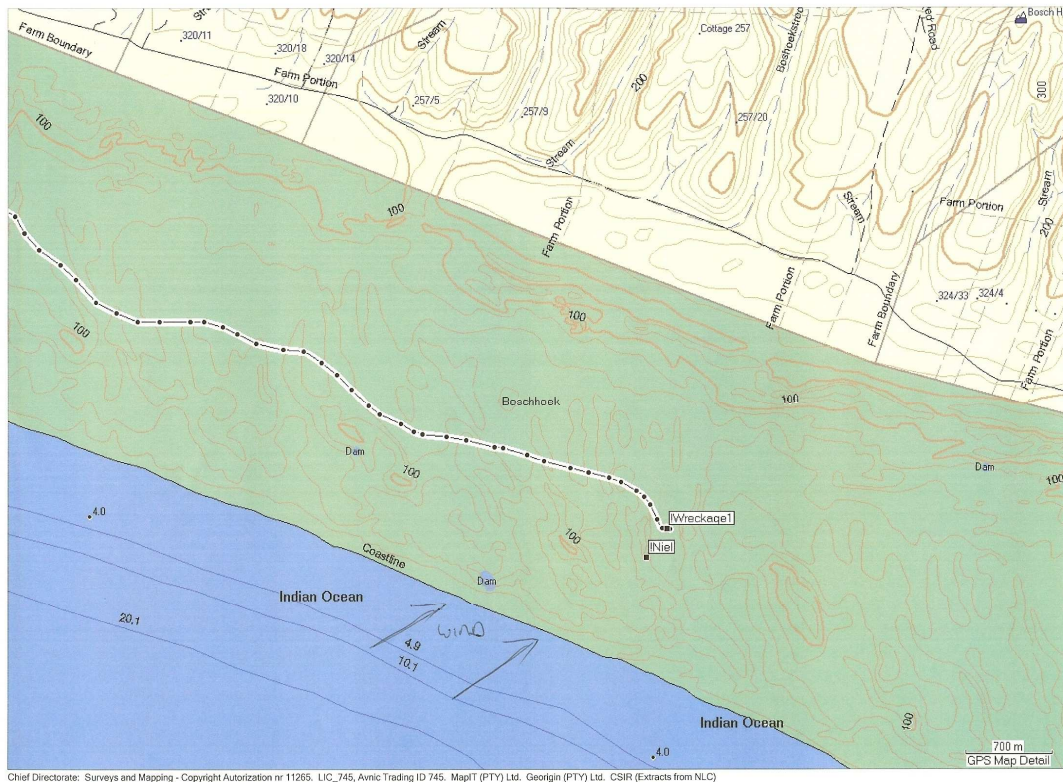
**Figure12:** GPS download indicating the track the pilot flew.

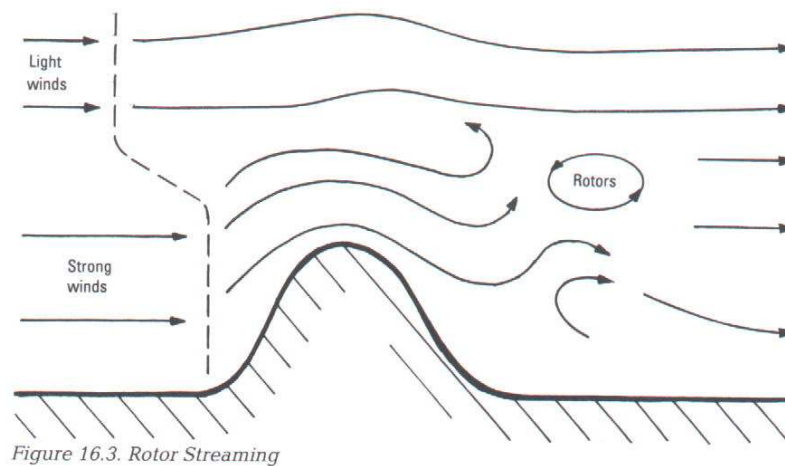
**Figure 13:** Rotor streaming.

- 2.5 The conclusion that can be drawn from the data is that the pilot possibly flew above but behind a sand dune and experienced wind rotors over the sand dune due to the wind blowing inland from the sea. He appeared to sustain a collapse on the left-hand side of the wing which brought on a spiral dive. It would seem that there was also a line-over problem on the left-hand side of the wing at the same time as the wing collapsed. After the wing collapsed, it would have re-inflated extremely fast due to the reflex technology, and this would have caused the ripping and burning effect on the wing surface seen on the photographic evidence. The line-over would only have been possible if there had been a wing collapse in the first place. The line-over problem on the left-hand side of the wing would then have kept that side of the wing collapsed. This in turn would have caused a high-speed descent and drift downwind with the heading change as indicated by the GPS co-ordinates. The pilot was unable to recover from the situation and with insufficient height to recover, impacted with the ground.
