## PARAGLIDER ACCIDENT REPORT AND EXECUTIVE SUMMARY

| | | | | Reference: | CA18/2/3/8584 | |

**Name of Owner/Operator** : Wojciech Siudek  
**Manufacturer** : Swing AG  
**Model** : Mistral 4-26  
**Nationality** : Polish  
**Place** : 10 km south of Venterstad  
**Date** : 16 November 2008  
**Time** : 1525Z

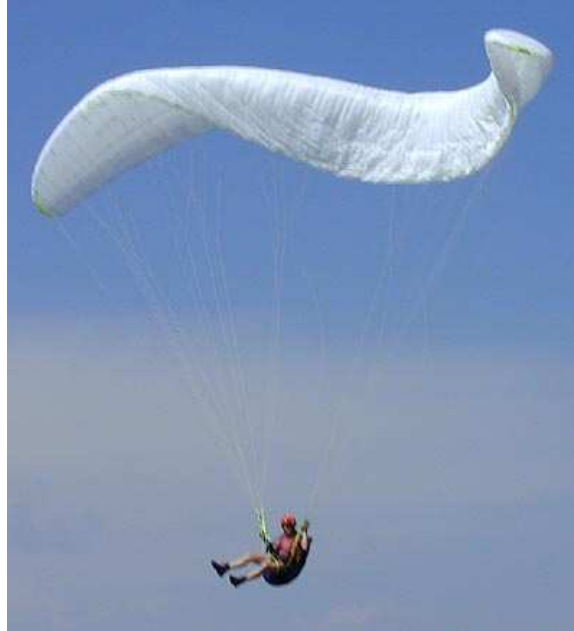
inflating the wing, in turbulent air, part or all of the wing can deflate (collapse). On modern recreational wings, such deflations will normally recover without pilot intervention. In the event of a severe deflation, correct pilot input will speed recovery from a deflation, but incorrect pilot input may slow the return of the glider to normal flight, so pilot training and practice in correct response to deflations is necessary” (See Fig. 1).

**Figure 1** A deflated wing (canopy).

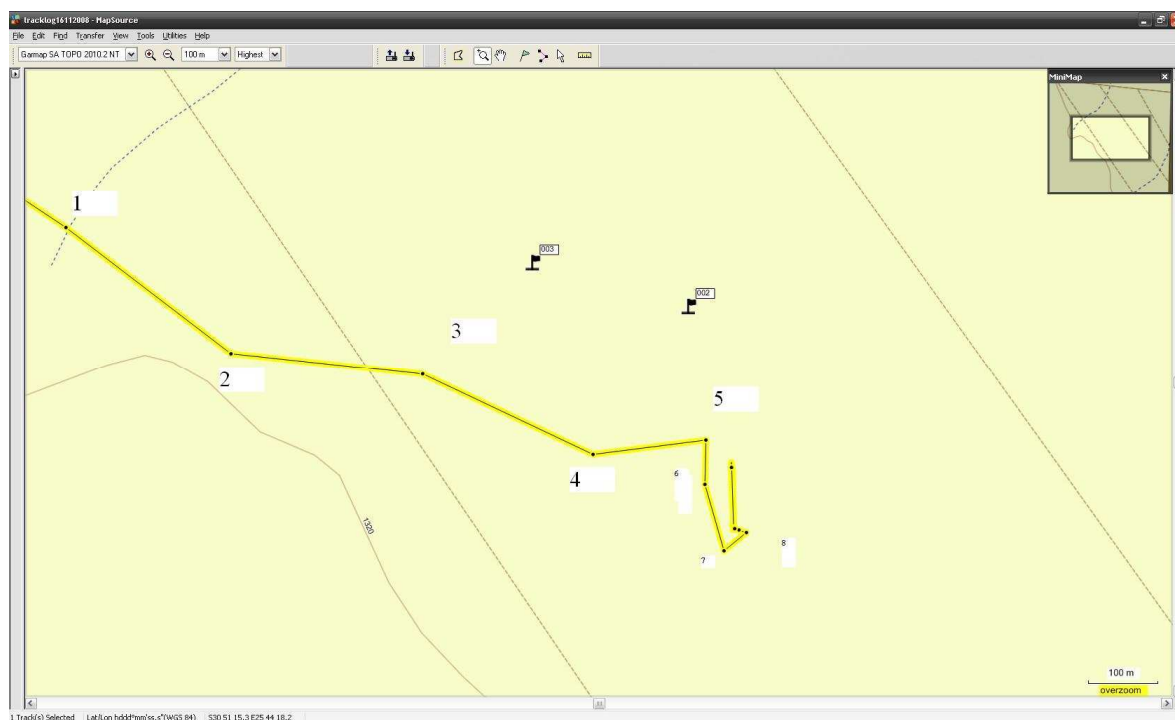
Track Log of the last part of the flight.

1.18.4 According to an expert appointed by the SACAA who conducted the investigation, evidence on the track log indicated the pilot was descending to land and there was a sudden change in direction to the right. During the change in direction, the speed of the paraglider dropped to 15 km/h, which is lower than the stall speed (22 km/h) of the paraglider. A sudden loss of altitude was also experienced during this phase of the flight. **(See Appendix A for the track log.)**

- Point 1 to 4 Normal glide – speed within range of glider – decent rate normal.
- Point 5 90 degree deviation of course and drop in speed. This is where I believe the deflation occurred on the right side, pilot at 1462m (ground at +- 1412-1416m) so pilot about 50m above the ground.

- Point 6 Glider speed very low, 15kph is less than the stall speed of the glider (22kph). This indicates that the glider was not in normal flying configuration. Pilot most probably trying to get glider to fly again.

- Point 7 Glider speed has increased but the pilot is losing more altitude. This is in my opinion the glider surging forward. Pilot still trying to recover glider

- Point 8 The Gliders forward speed is once again very low and the pilot lost +-15 meters. At this point the pilot has lost control of the glider and this is the point of impact.

- All points after this is the pilot being dragged on the ground.
