**PARAGLIDER ACCIDENT REPORT AND EXECUTIVE SUMMARY**

| | | | | Reference: | CA18/2/3/9123 | |
| <b>Aircraft Registration</b> | Not Applicable | <b>Date of Accident</b> | 10 January 2013 | | <b>Time of Accident</b> | 1221Z |
| <b>Type of Aircraft</b> | Paraglider | | <b>Type of Operation</b> | | Recreational | |

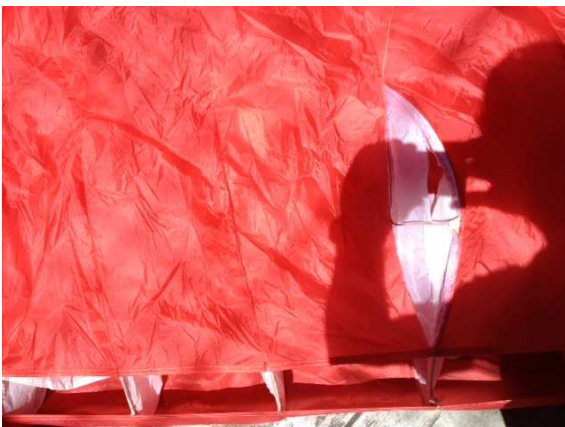
1.3.4 The paraglider's upper wing surface showed distinct signs of tear damage. The paraglider wing had burst two cells (cells 5 and 8, counting outwards from the centre label) on the lower surface a metre apart, off-centre and on the leading edge to the left.

**Fig. 1** Bottom skin cell wall burst

This damage is typically from the open (leading) edge coming into contact with the ground and air being compressed under huge pressure and bursting rib stitching.

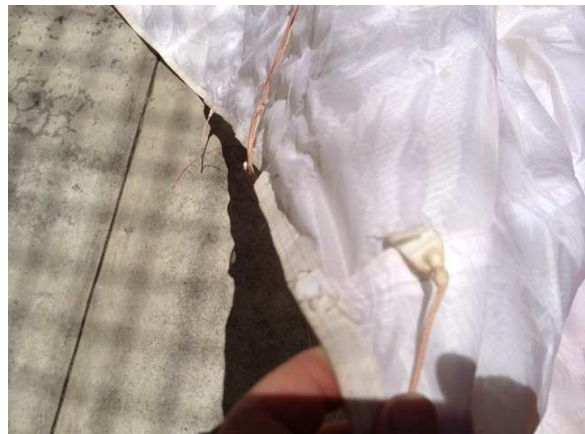
1.3.3 The SAHPA investigation team found that the paraglider's main canopy lines had been cut to create working space for the rescue personnel, and it was not possible to inspect the lines for failure.

**Fig. 2** Broken line shear

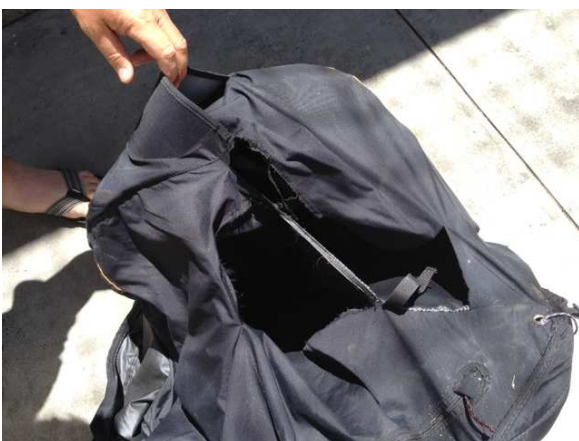
**Fig. 3** Harness base tear

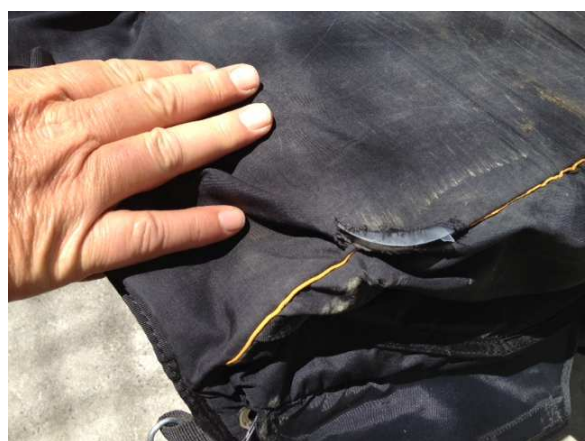
**Fig.4** Harness frontal tear

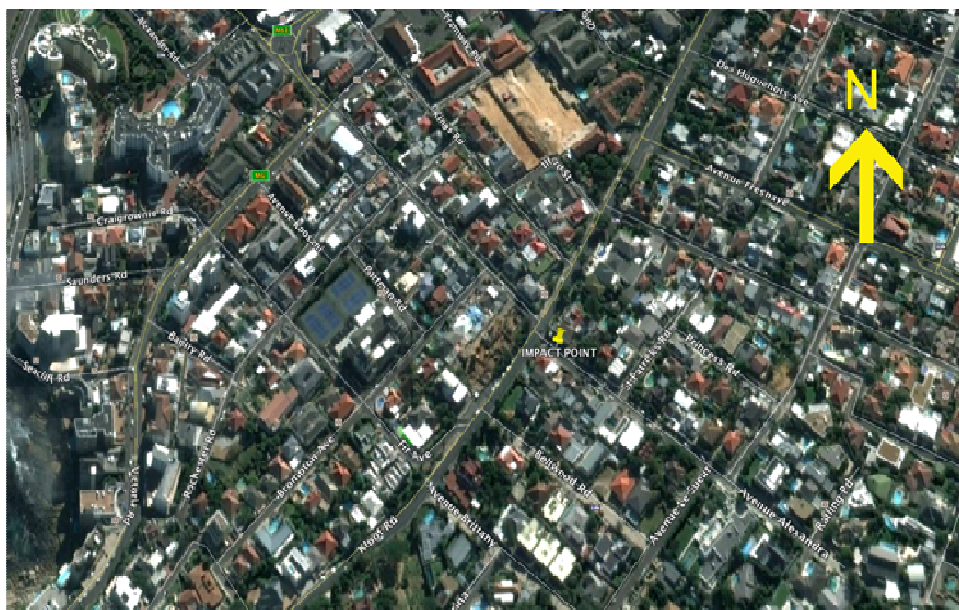
- 1.12.2 The paraglider crashed into a boundary wall of a residential home at the corner of Kloof Road and Alexandra Avenue, Fresnaye, Cape Town. The pilot's body was flung into the cast iron gate at the entrance to the property.
- 1.12.3 This impact was of such force it broke two welded bars from the decorative gate and bent the metal towards the house, away from the street.
- 1.12.4 The paraglider's canopy was found to the right on the sidewalk, marked with an unknown white powder.
- 1.12.5 The crash site location and impact points were within a 7 m radius.

**Figure 6:** Google map image of the impact point

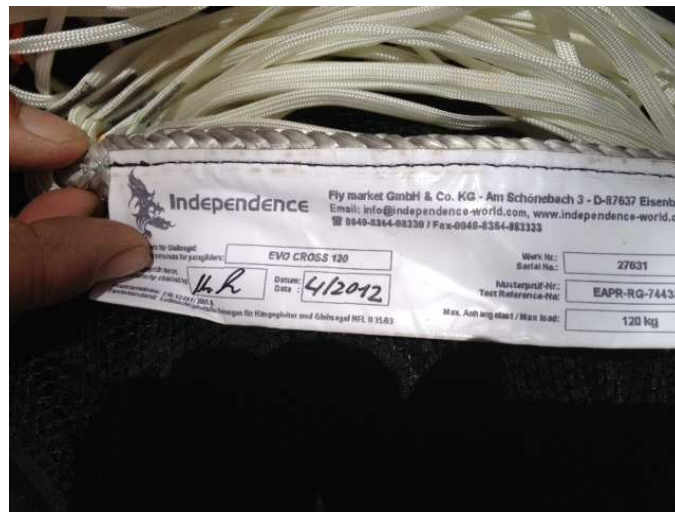
- 1.15.1 The reserve parachute had not been deployed. It was found intact after the accident. If it had deployed there is a chance that it might have prevented this fatality, although injury would still have been highly likely.
- 1.15.2 The harness was an approved model and incorporated an airbag compartment that offered some low-level protection to the pilot when making a “normal but hard landing”. The airbag container had, however, experienced impact forces that exceeded its limitations and burst open.

1.15.3 The combination of the undeployed parachute and high impact forces experienced did not make this accident survivable.

**Figure 8:** The un-deployed parachute

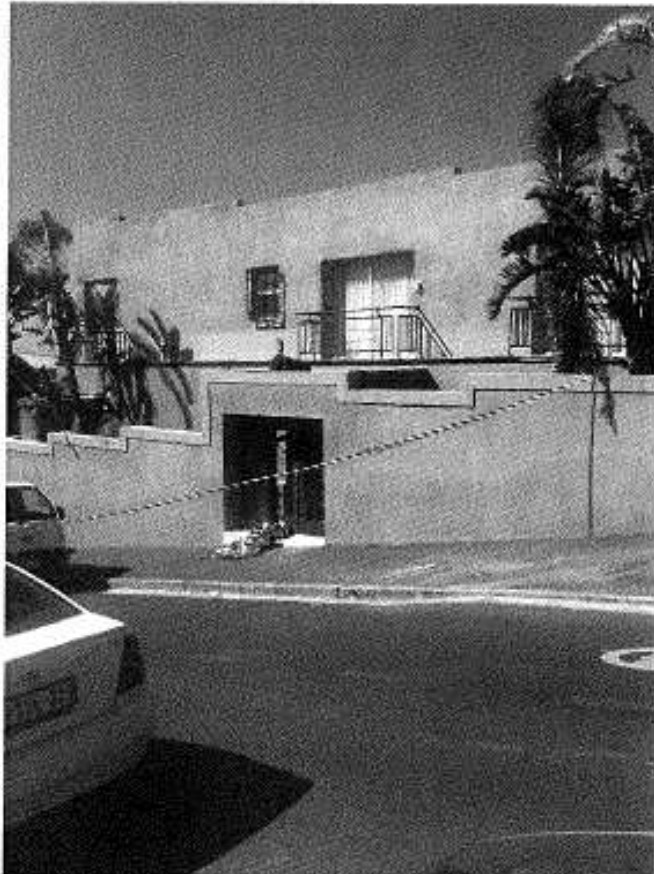
Crash scene and body of the deceased in the position he came to rest post impact with the entrance façade and gate. The paraglider canopy had lain to the right on the sidewalk marked with an unknown white powder, directly below the candy tape shadow casting a vertical line on the wall (paraglider and harness cut off by responders and placed in SAPS van on scene).
