# Preliminary Accident Investigation Report

**Reference Number:** SAHPA/151/17/02/2025

**Aircraft Type:** Paraglider (Air Design Rise 5)

**Investigation Authority:** South African Hang Gliding and Paragliding Association (SAHPA)

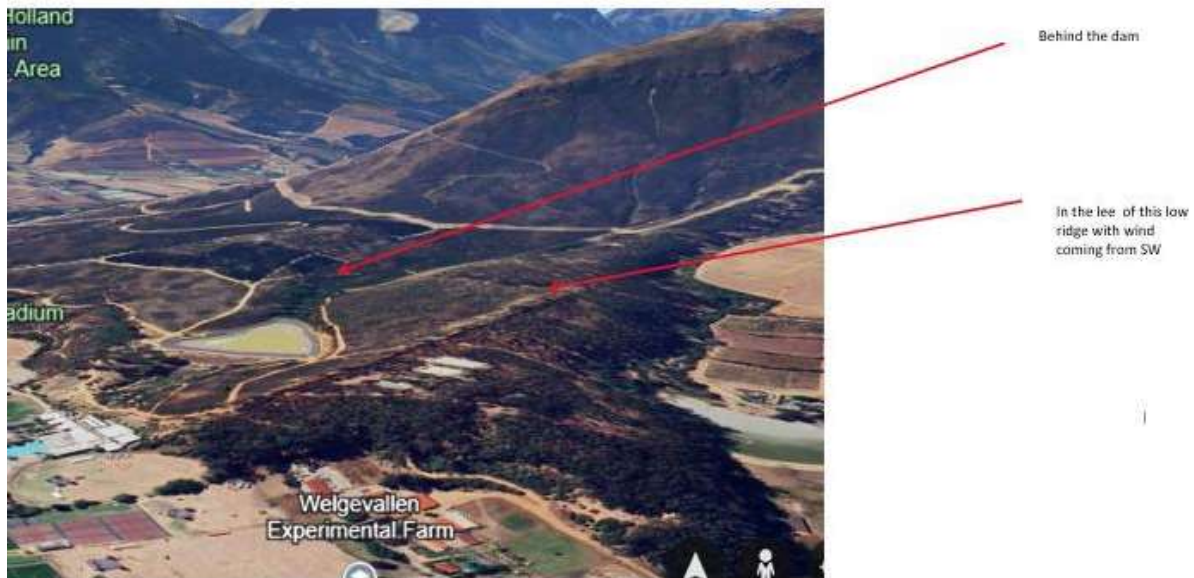
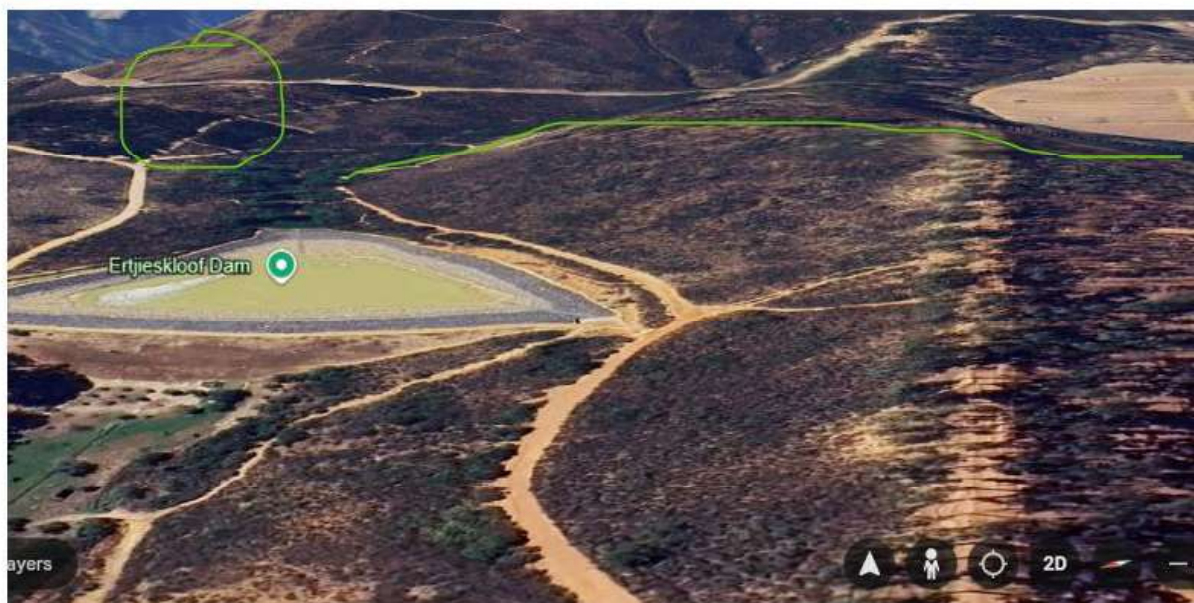
You can see how it accelerates to the right due to the southwest wind or a thermal. The height on the small hill is 40 meters higher than the trees. The flow accelerates because it looks like an airfoil profile from the dam's side. The lip of the dam wall also causes turbulence and release.

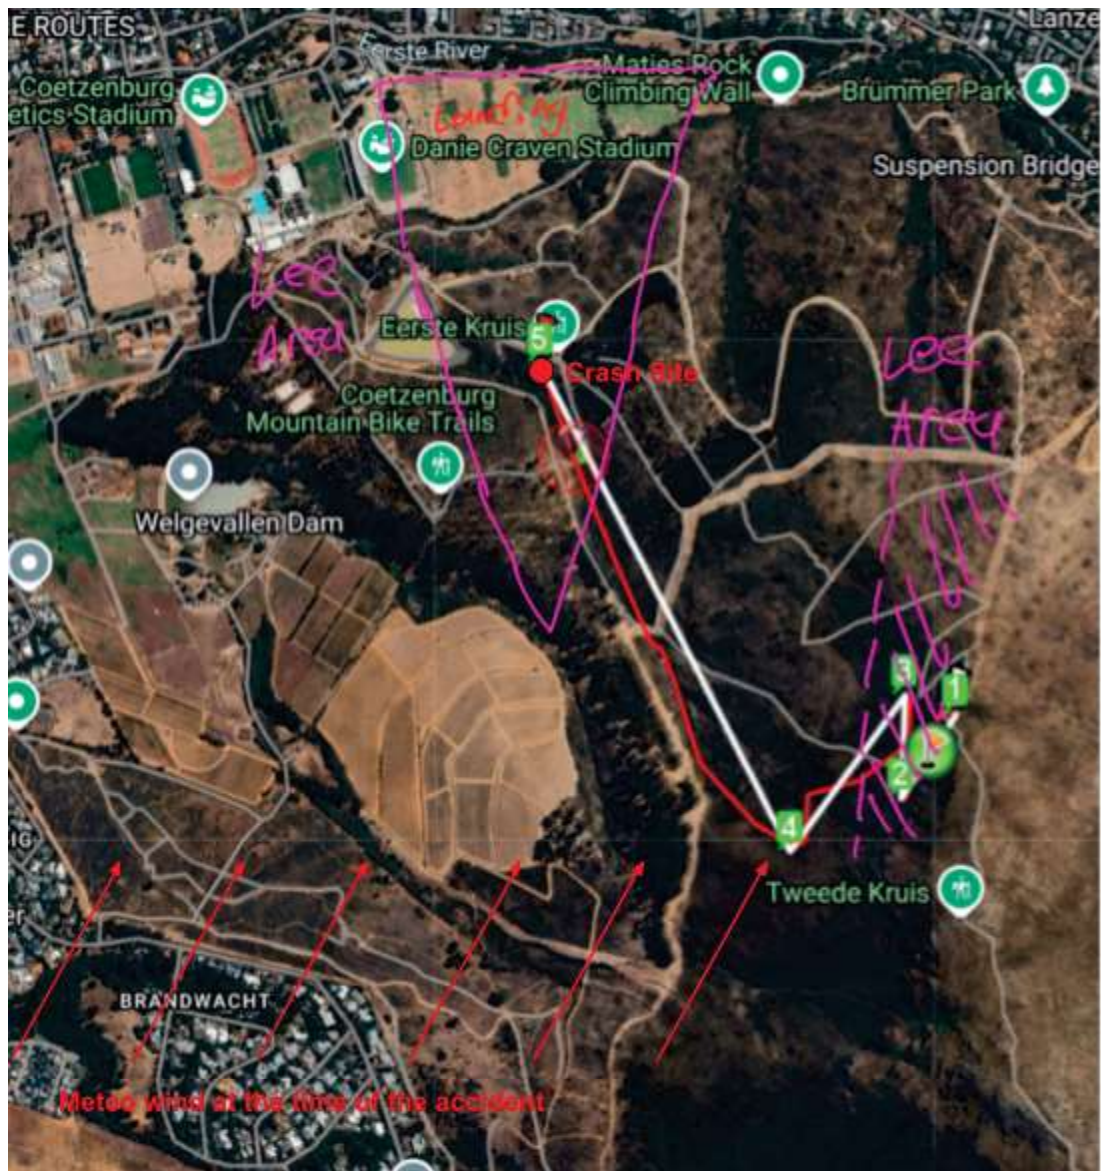
Unfortunately in many conditions (especially SW wind) the macro terrain of the Stellenbosch & Jonkershoek mountains funnels the winds up the Jonkershoek valley and creates a strong venturi effect that wraps around Stellenbosch mountain. This wind generally starts mid-day and can pick up significantly during the afternoon, despite relatively mild meteo winds.

It washes wind *down* from the Coetzenburg dam area, over the trees high above the landing and over the very large Coetzenburg stadium building.

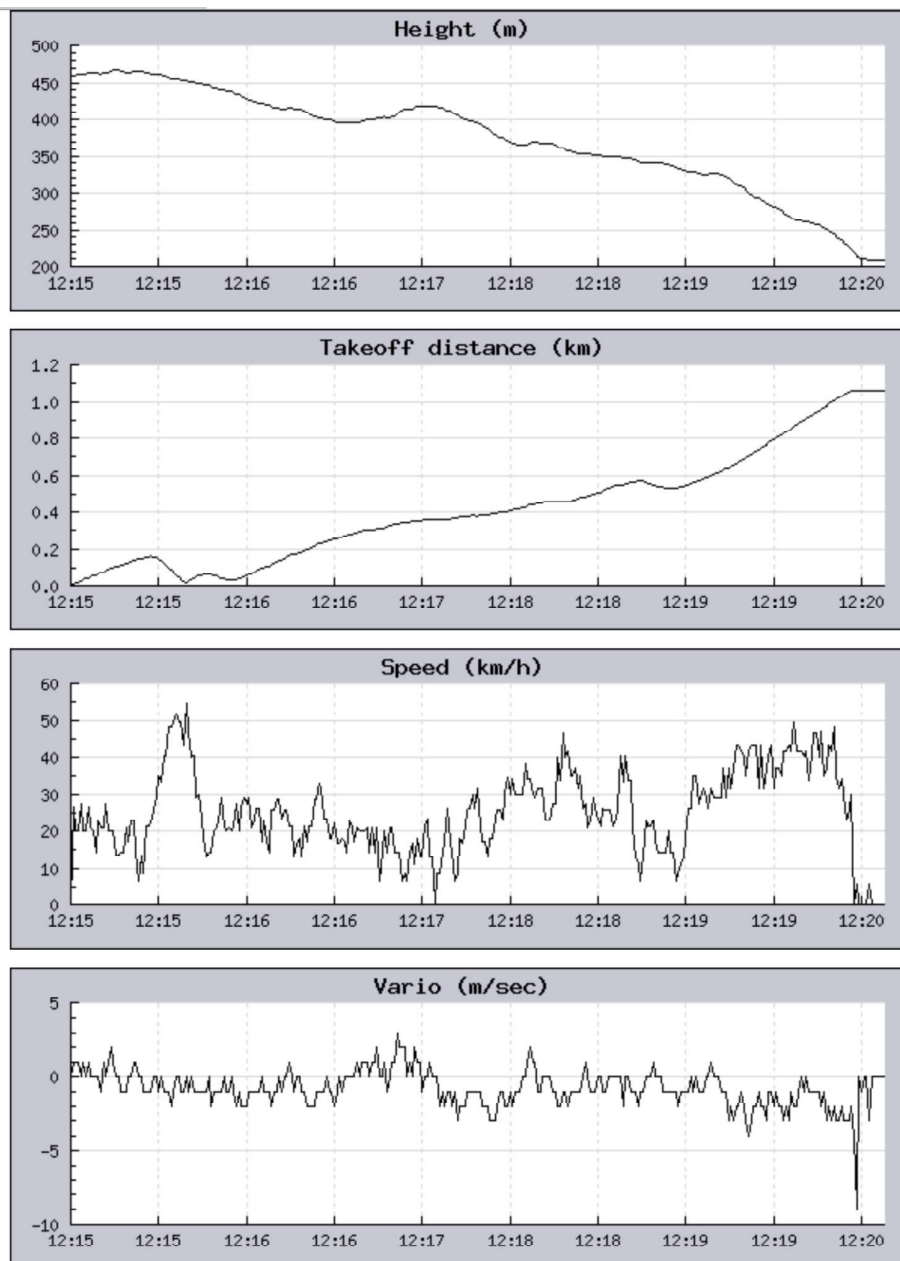
### Vario readings of the flight

Note: The vario readings indicate a very significant descent rate (approaching 10m/s - 36 km/h vertical descent speed) immediately preceding the crash. This exceeds the typical descent rate of a stalled paraglider, and is in line with a paraglider in a deep spiral or auto-rotation configuration.

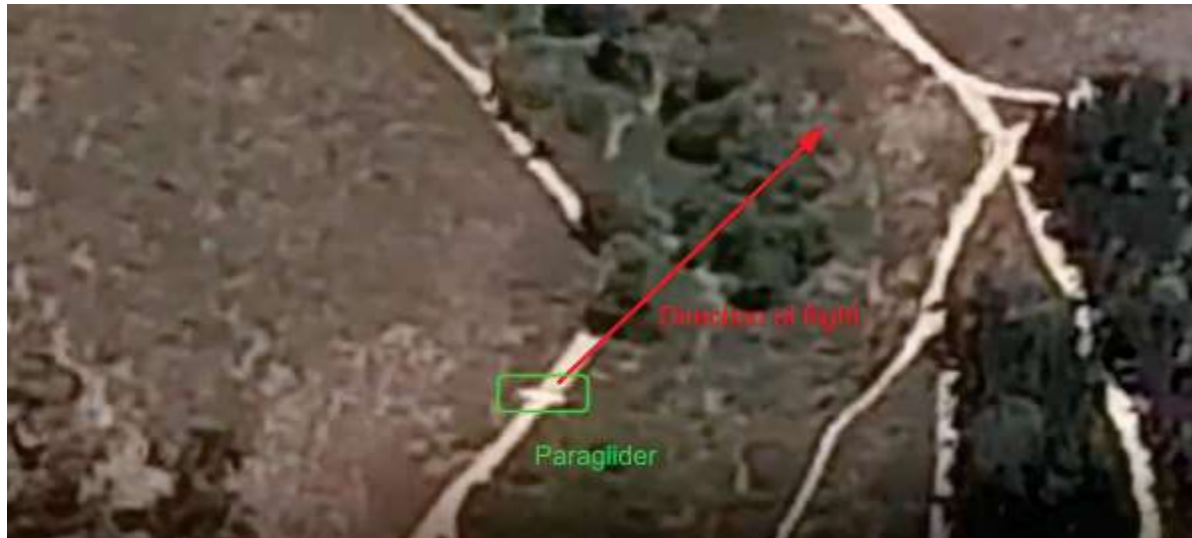
### Frame 1: approaching accident location

**Analysis:** The glider is flying normally, the pilot is about to cross a gully towards a ridge line that could take the pilot to landing. Based on the tracklogs the glider is approximately 40-50m or less AGL. The pilot is encountering mild sink and descending at ~2m/s.

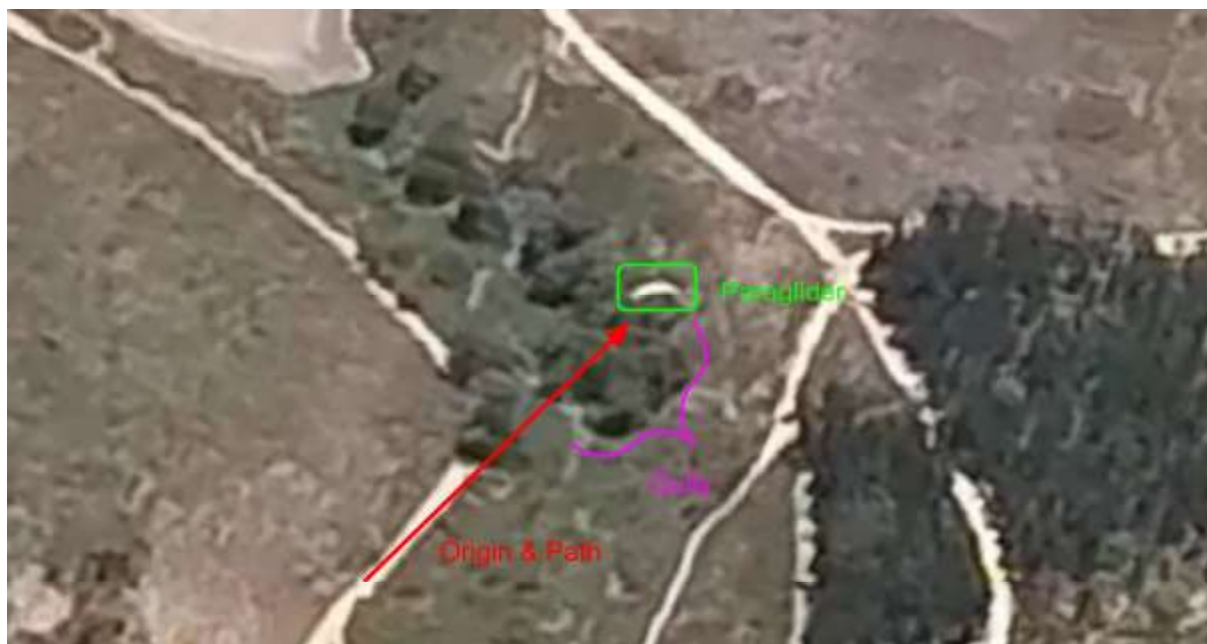
### Frame 2: passing through green and moist gully

**Analysis:** The pilot navigates across the small gully, encountering reducing sink (-1.3m/s). The gully has green, leafy vegetation and moist ground. This would create a significant thermal contrast with the dry, barren, vegetation on the sides of the gully.

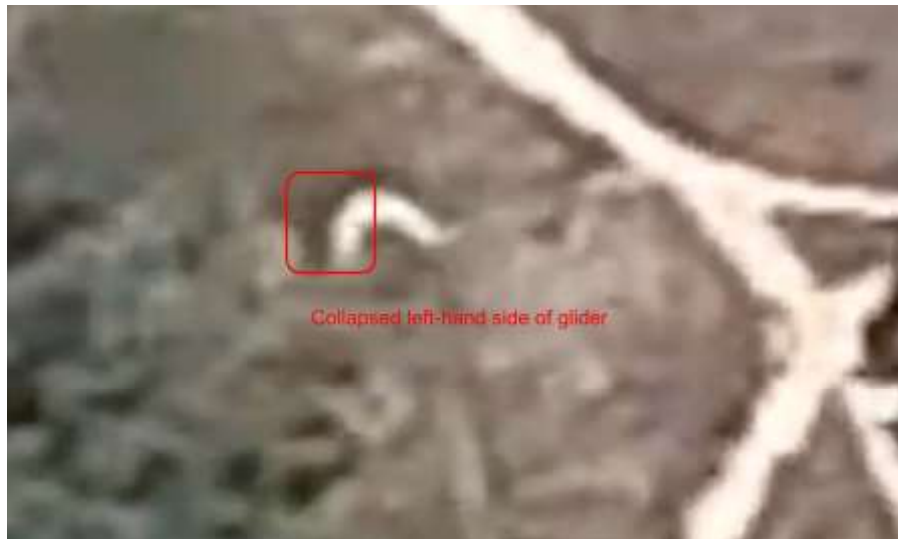
### Frame 3: Evidence of glider collapse on left hand side

**Analysis:** It appears that the glider suffered a collapse on the left hand side. The glider starts rotating counter-clockwise, consistent with a left hand side collapse.

At this point the pilot is less than 40m AGL, based on the track logs.

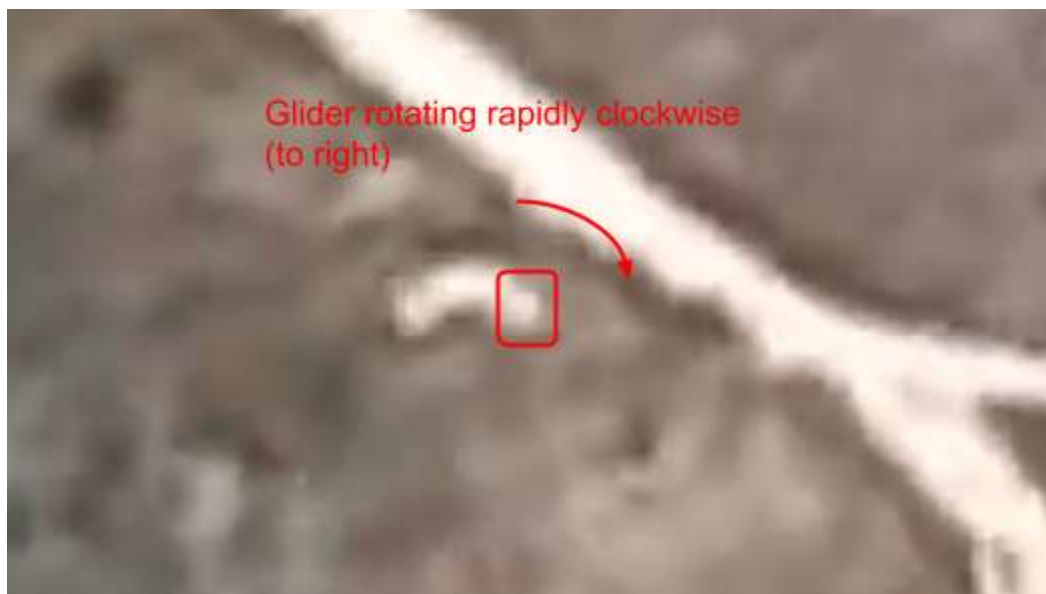
### Frame 4: Evidence of potential clockwise spiral initiation

**Analysis:** After approximately 1 second, the right hand side of the glider appears deformed and the glider starts rapidly rotating clockwise.

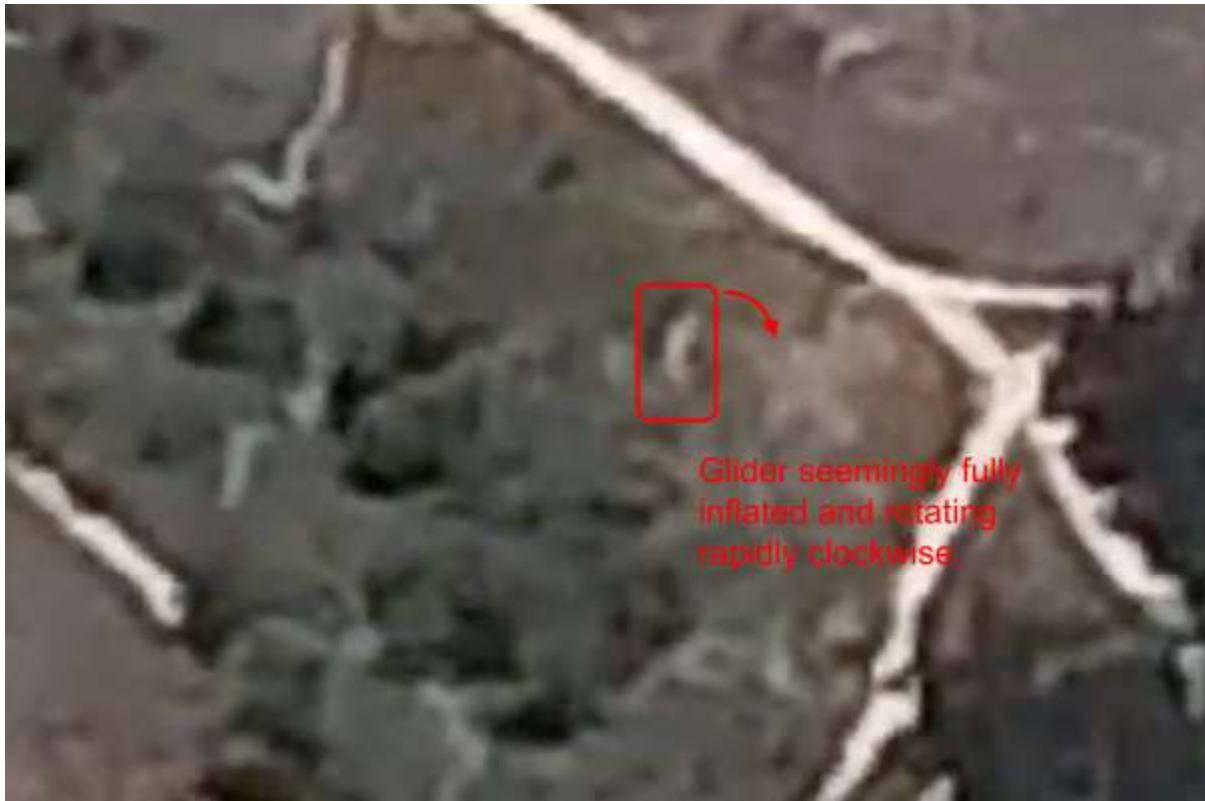
#### **Frame 5: Glider seemingly in clockwise spiral**

**Analysis:** At this point the glider seems to be in a rapid spiral or auto-rotation descent.

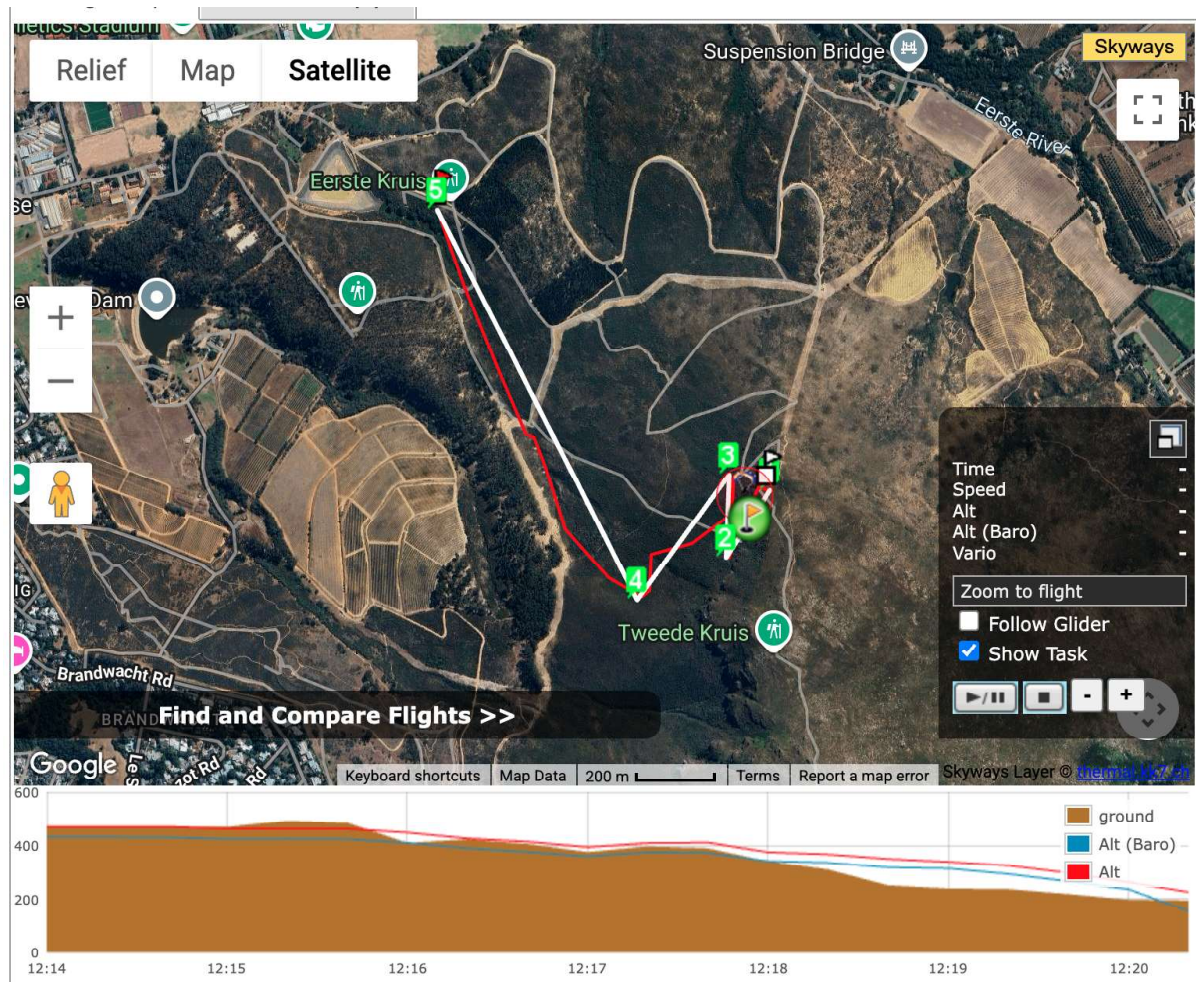
### Flight Path Analysis

The IGC tracklog shows that the pilot was flying close to terrain at Stellenbosch Mountain.

This flight path may have placed him in an area prone to mechanical turbulence caused by the interaction of the increasing south/southwest wind with the mountain terrain. The Coetzenburg dam area and associated topography, when combined with the wind direction

2. **Recommendation:** Pre-commit to personal minimums for AGL clearance, factoring in thermic conditions and risks of mechanical turbulence. Be disciplined about abandoning the search for lift and head to a safe landing at a safe altitude if these personal AGL clearance minimums cannot be maintained.

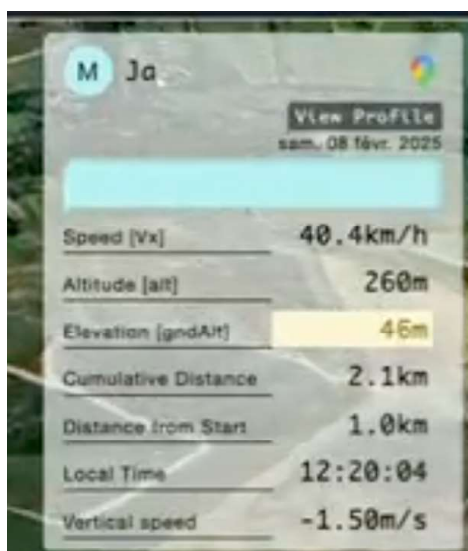
Based on the analysis of the tracklog using a number of applications and 3D perspectives of the terrain, it can be said with confidence that the pilot was less than 80m AGL immediately preceding the accident, and quite likely less than 50m AGL.

[Analysis using Sports Track Live showing 46m AGL immediately prior to accident]

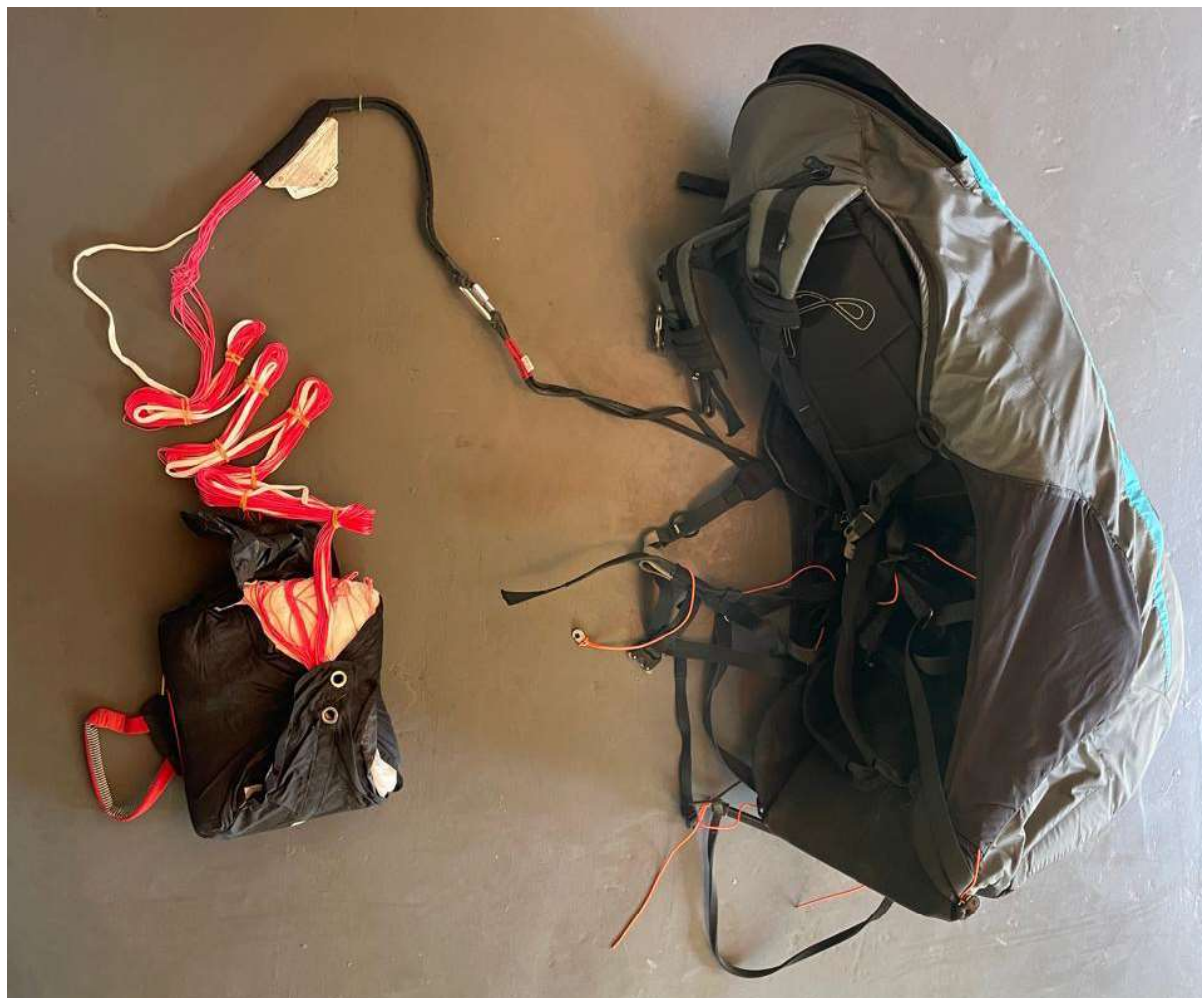
#### Harness & reserve

The pilot's reserve parachute was found outside the harness pocket, but still packed in its container. This could indicate a failed reserve deployment, or simply the ejection of the reserve parachute due to the impact of the crash.

Note: Reserve out of harness pocket, but still in container and undeployed.
