# Final Accident Report

**Figure 1:** Solo paraglider flight resulting in a fatal accident on the east side of Piekinierskloof Pass (N7) near the town of Citrusdal in the Western Cape

**Reference Number:** SAHPA/148/10/02/2025

**Model:** Guru

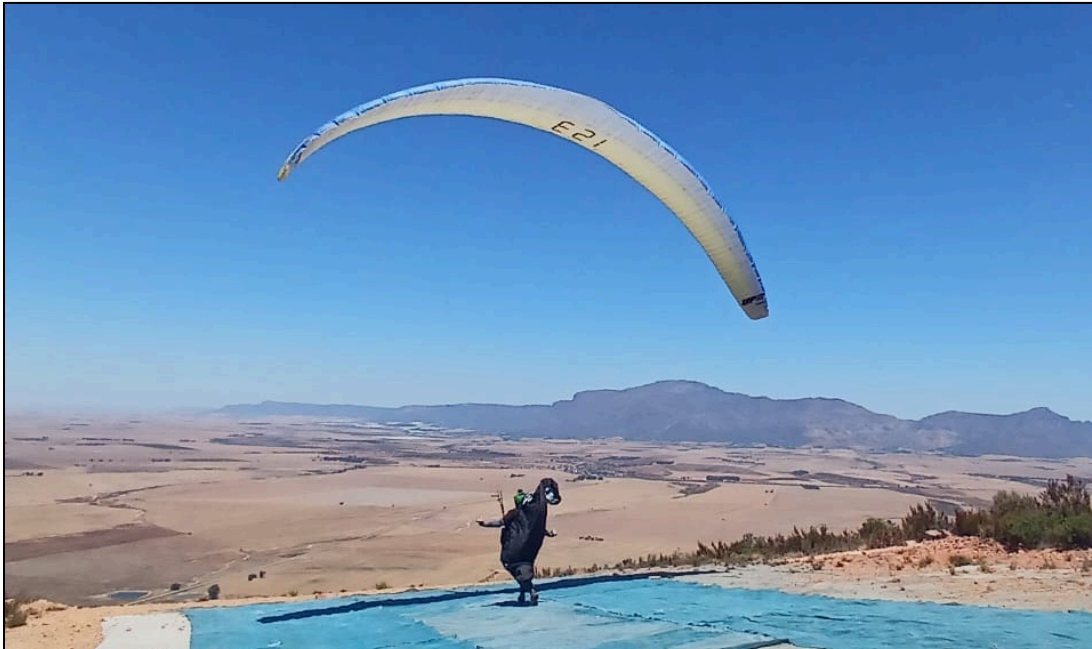
**Figure 6:** Photo captured at the start of the flight (source Facebook)

- Weather Actual: The photo in Figure 6 shows a sunny, blue sky day, typical for this region in summer.
- Weather Forecast: The forecast from the RASP weather model (Table 2) shows an average summer day with medium-strength thermals and full sunshine. Surface wind forecast was 7kph and 15kph at 11h00 SAST and 14h00 SAST, respectively.
- Thermal drift calculations at the start of the flight provided a wind speed and direction of **9.8kph from 237 degrees**
- The river water was calm and slow-moving at the time of recovery - the rescue diver found it easier to start from a downstream position (due to easier access through the river foliage) and swim upstream to the accident scene.

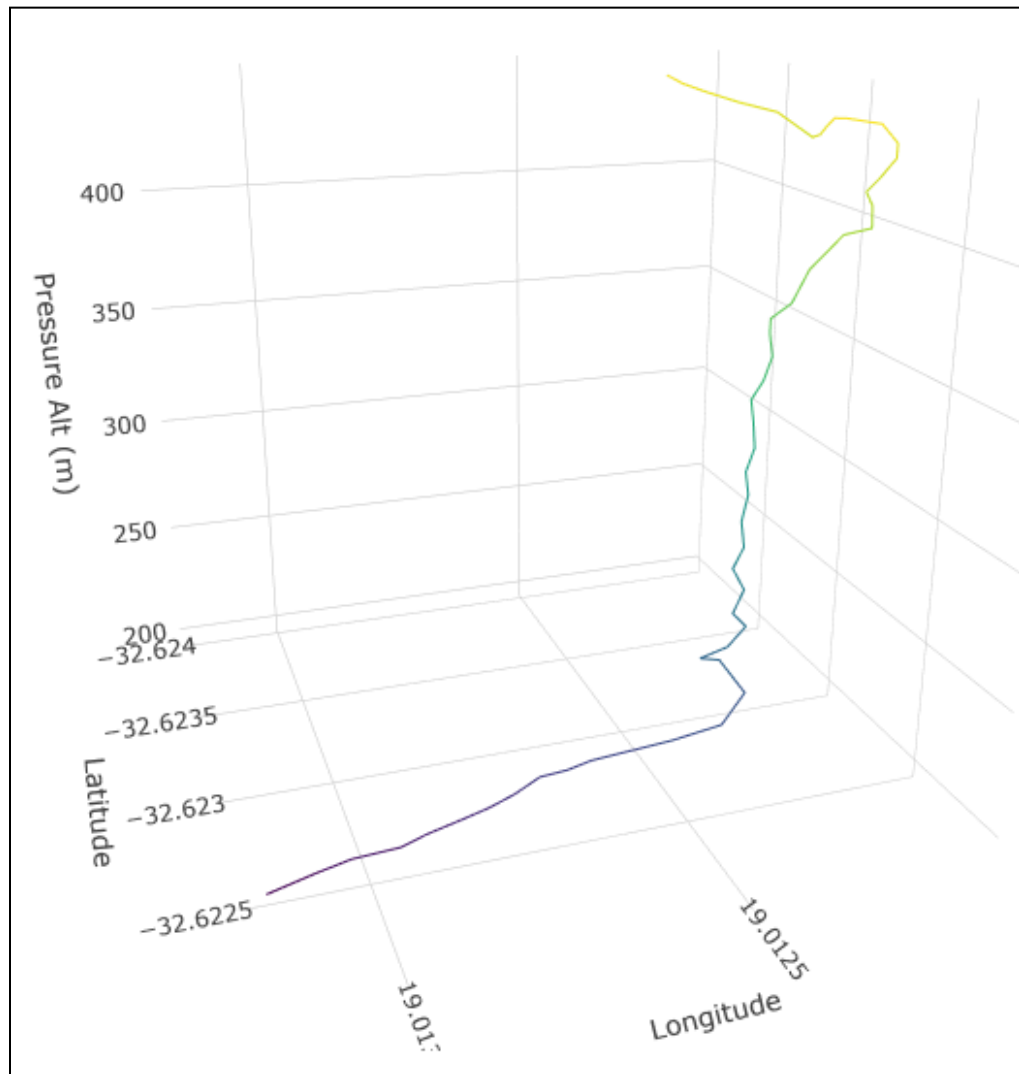
**Figure 7:** 3D flight path analysis in the last 60 seconds of flight

- Between 10:30:48 UTC and 10:31:06 UTC, he flew parallel, upwind, and alongside the Olifants River at an altitude of ~240m AGL
- He started to climb quite strongly (4-5m/s) at 10:31:03 UTC for 4 seconds before encountering strong sink (4-6m/s), which got stronger, averaging 7m/s loss of altitude for the next few seconds before a peak of 11m/s sink at 10:31:35 UTC (See table 3 and figures 7 & 8).

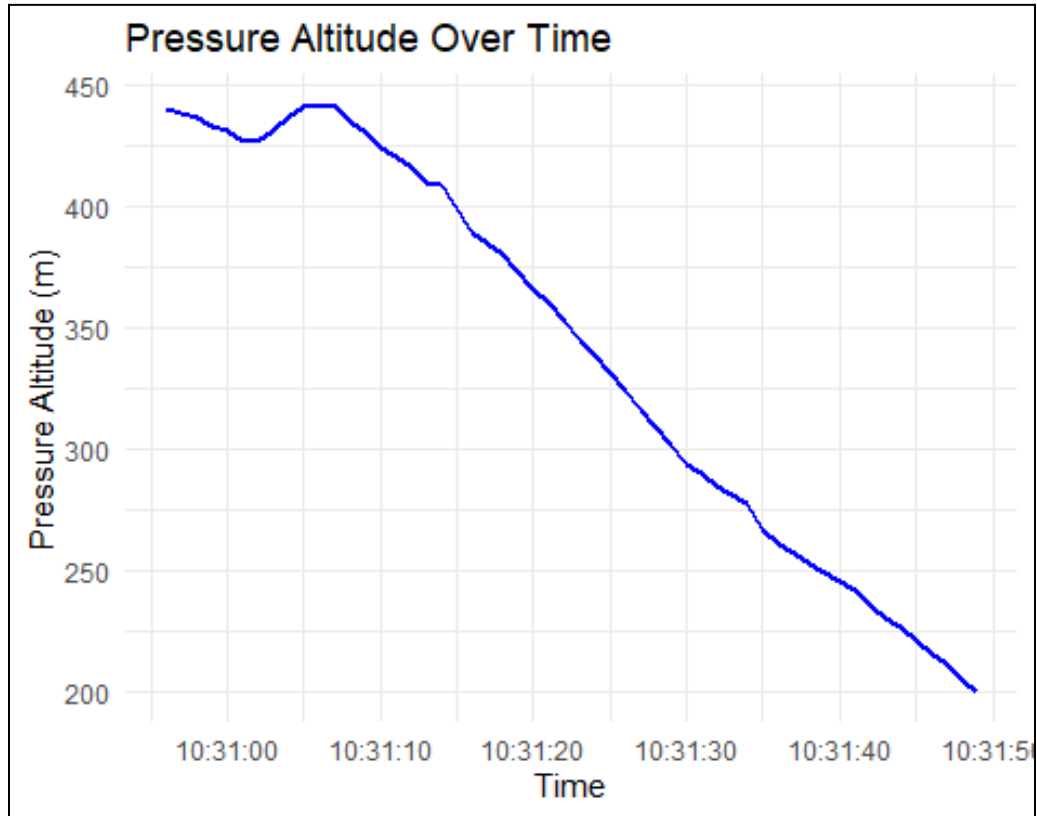
Figure 8: Tracklog data showing height over time (Time in UTC)

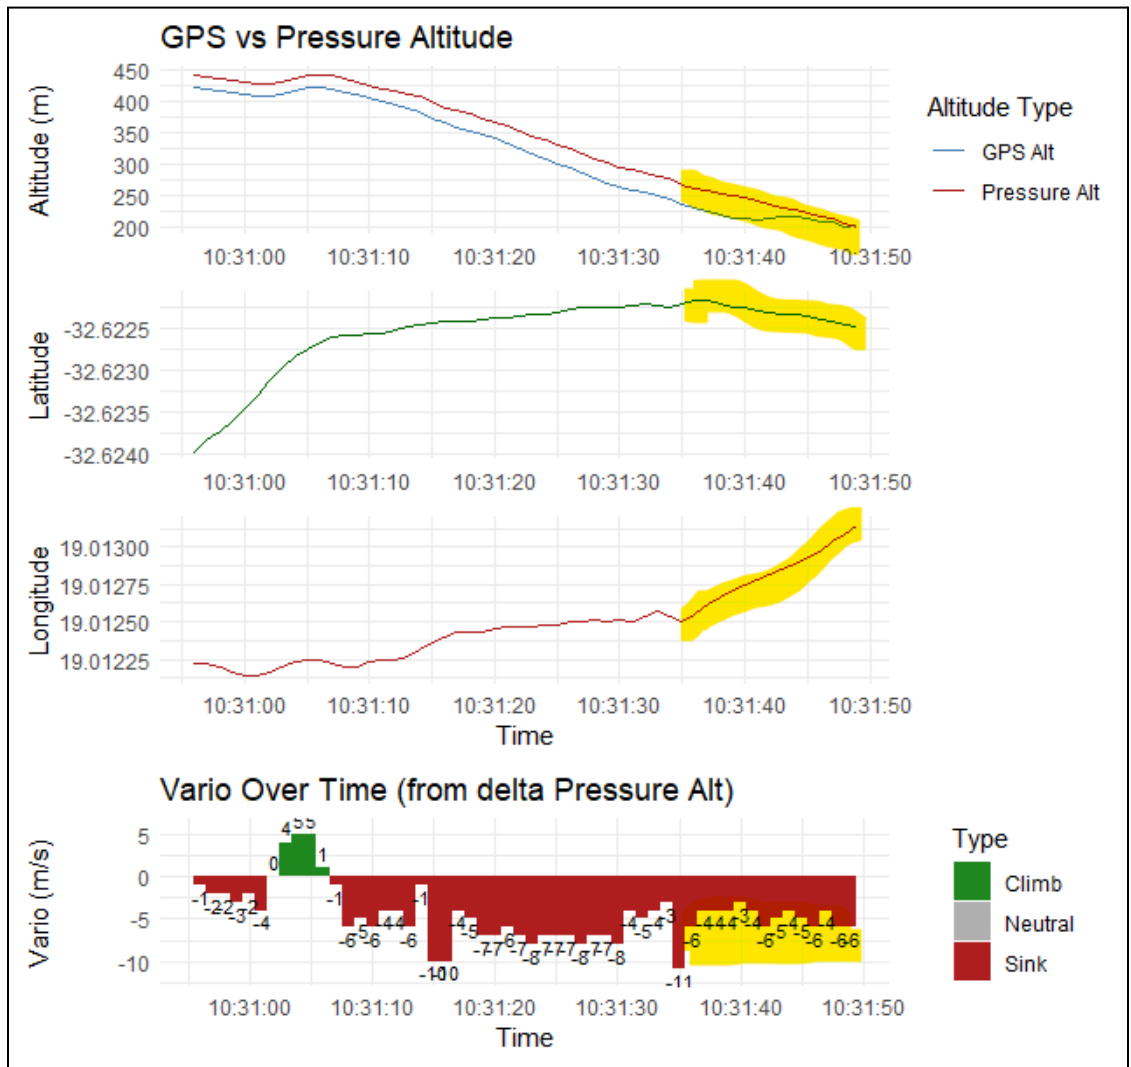
**Figure 9:** Tracklog data plotted by time. Areas highlighted in yellow are deduced to be those under which the reserve parachute was deployed (Time in UTC).

- From 10:31:36 UTC, the sink rate varies around 4-6m/s along with a consistent change in latitude and longitude (see figures 9 & 10). These numbers are consistent with behaviour seen during reserve parachute descent.

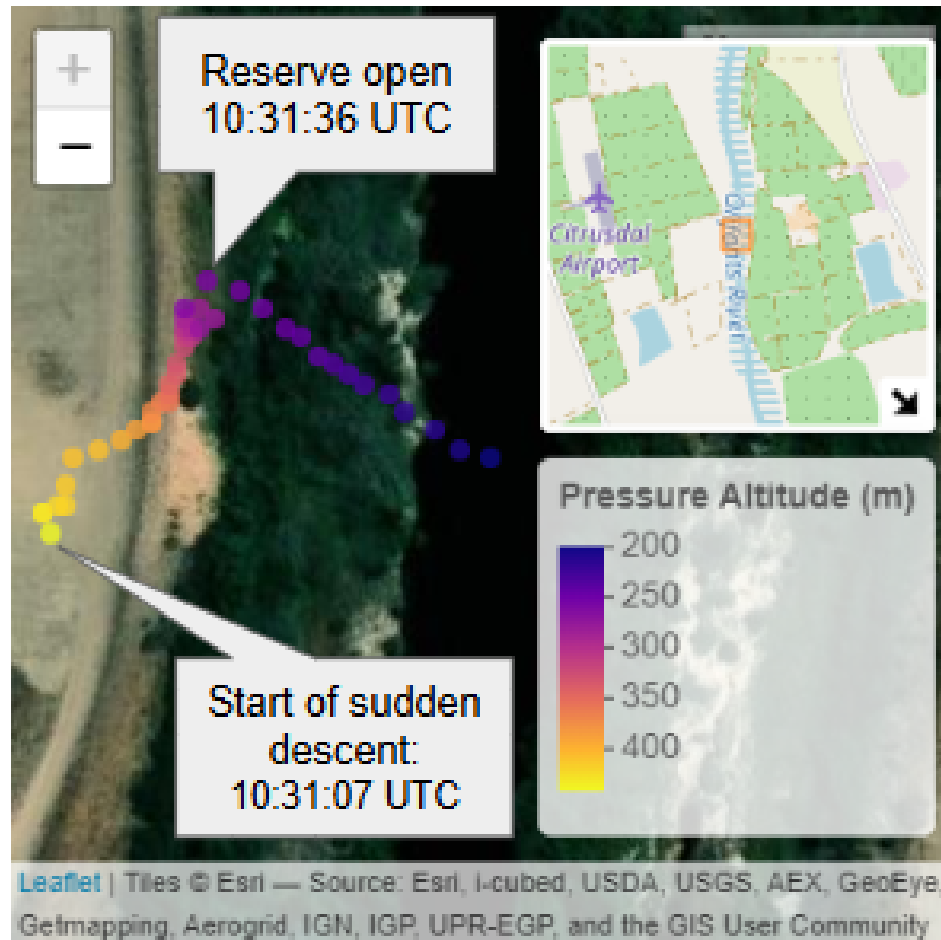
**Figure 10:** Tracklog positional data plotted on a map from 10:31:07 UTC to 10:31:49 UTC

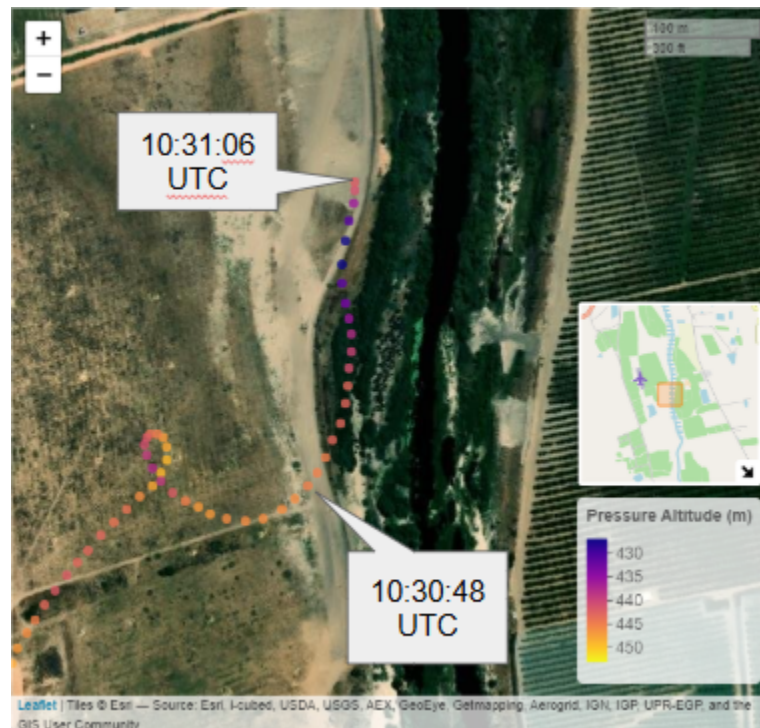
**Figure 11:** Pilot flies parallel and alongside the river at an altitude of ~240m AGL from 10:30:48 UTC to 10:31:06UTC (before the start of the sudden descent)

- The route selection was consistent with standard XC patterns and did not raise concerns at the time. Crossing or flying in the vicinity of the river would not have been a factor in his in-flight decision-making due to the river being sufficiently narrow to not appear as a possible hazard, especially from 240m+ above ground level. However, it should be noted that he did fly parallel to the river on the upwind side between 10:30:48 UTC and 10:31:06 UTC
