# PARAGLIDER ACCIDENT REPORT AND EXECUTIVE SUMMARY

| | | | | Reference: | SP003/2011 | |

**PARAGLIDER ACCIDENT REPORT**

**Name of Owner/Operator** :Oleg Thomas  
**Manufacturer** :Advance  
**Model** :Sigma 7  
**Nationality** :Moldovan  
**Place** :8 km north of Porterville  
**Date** : 16 December 2011  
**Time** :0943Z

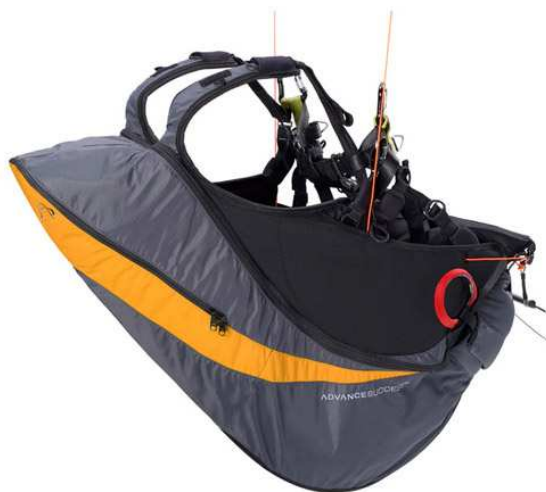
**Figure 1**Open Harness

Two main types of harnesses are used in Paragliding. The first and most common type of harness are referred to as open harnesses with a more upright seating position and where the legs are exposed. The main support straps are visible to the pilot.

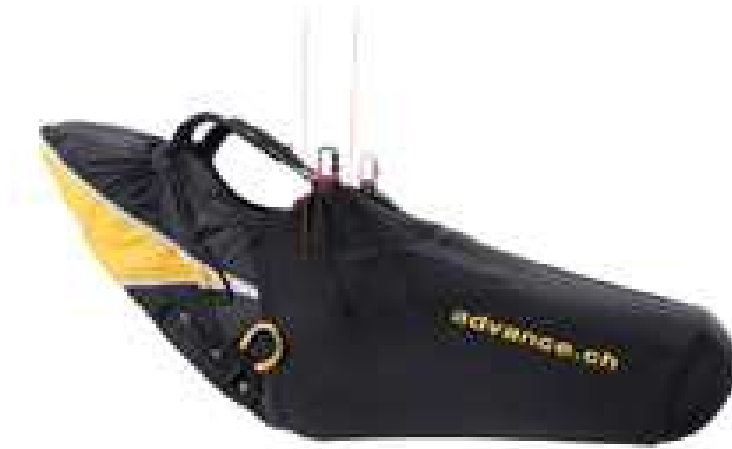
**Figure 2 Cocoon Harness**

The second type of harness is the cocoon harness that has an aerodynamic fairing that covers the pilot's legs and abdomen. The main support straps that run thru the legs are not visible with the fairing done up. The seating position is very supine. This is the type of harness used most often in competitions.

**Appendix C** Illustrates how it is possible to forget to do up the main support straps on a cocoon harness.

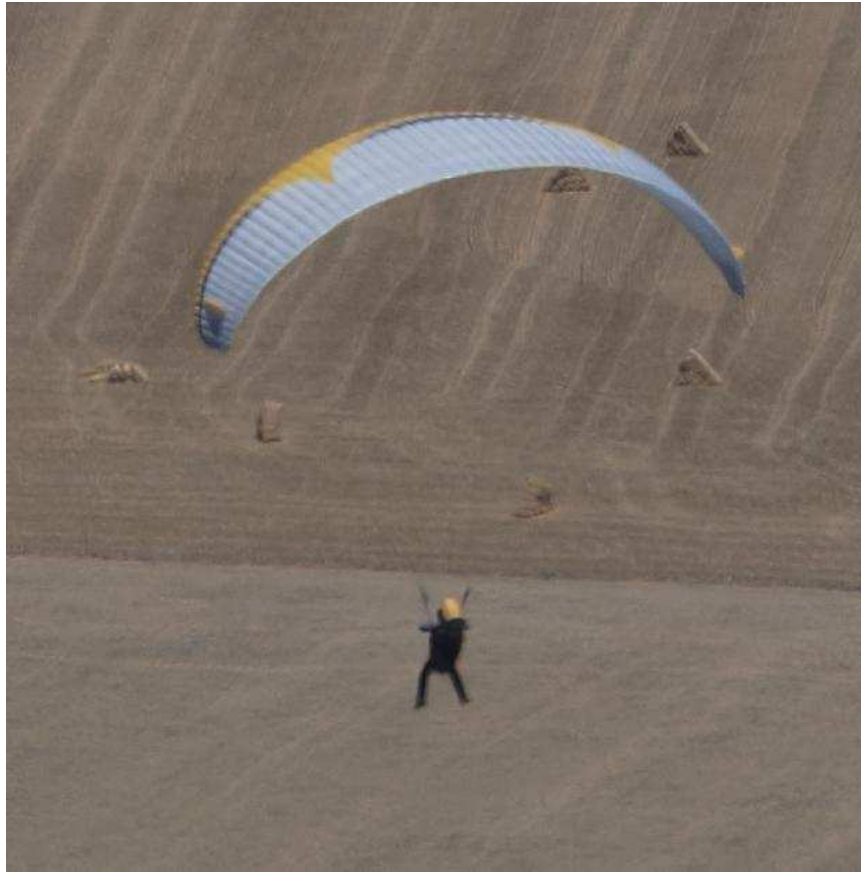
This photograph was taken about 2 minutes after the pilot launched. It is clear that he is hanging low in the harness and the support straps is not done up. He has his arms locked around the shoulder straps and risers of the glider.

- 2.4 Photographic evidence indicate that the pilot did not do up the main support straps of the harness before launching. The main support straps were obscured by the aerodynamic fairing that was done up and further by an instrument panel that was also attached.

- 2.6 Once airborne the pilot locked his arms around the shoulder straps and risers, while attempting to get purchase with his legs. The pilot slipped further and further down the harness until he lost his hold and plunged to his death. Photographs in **Appendix A**

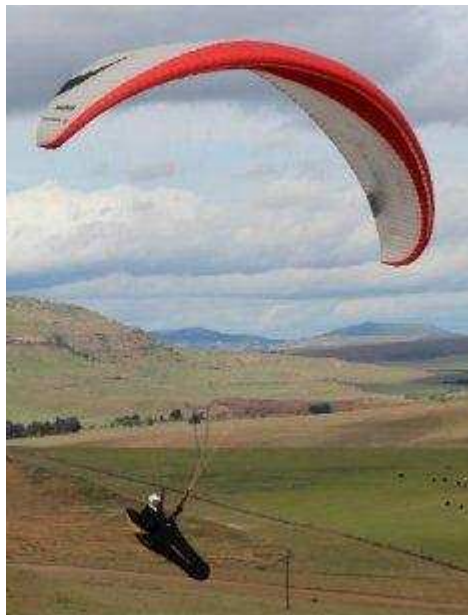
Reference photograph of another pilot in same harness in normal flying configuration.

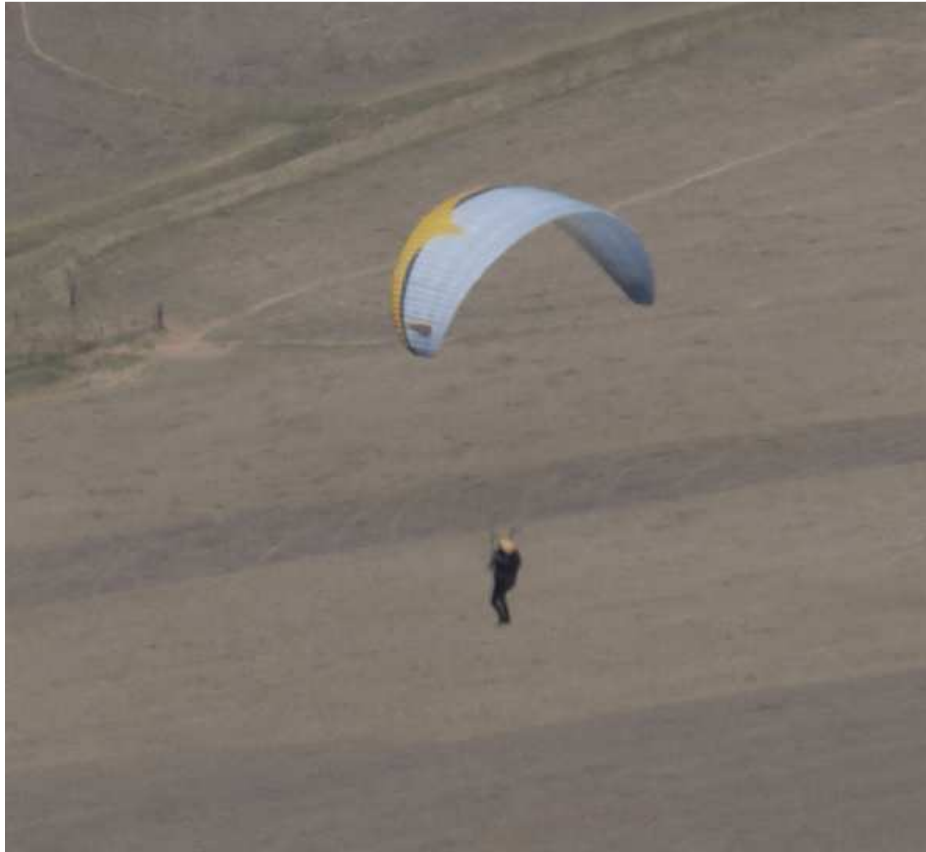
Pilot has slipped down further in the harness.

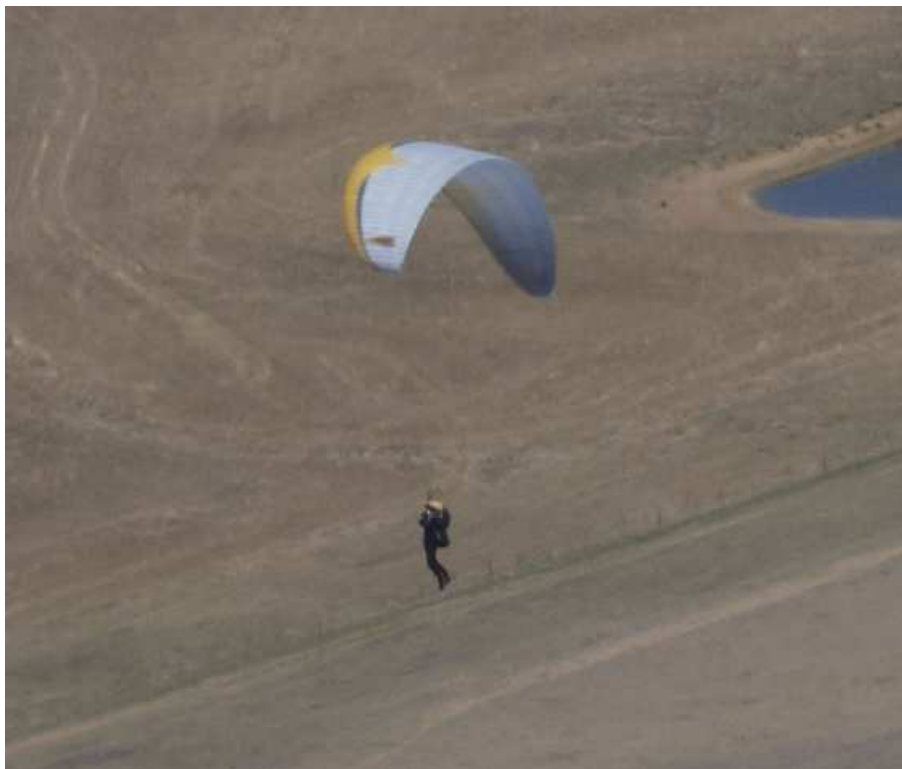
Pilot milliseconds from loosing his grip and plunging to his death.

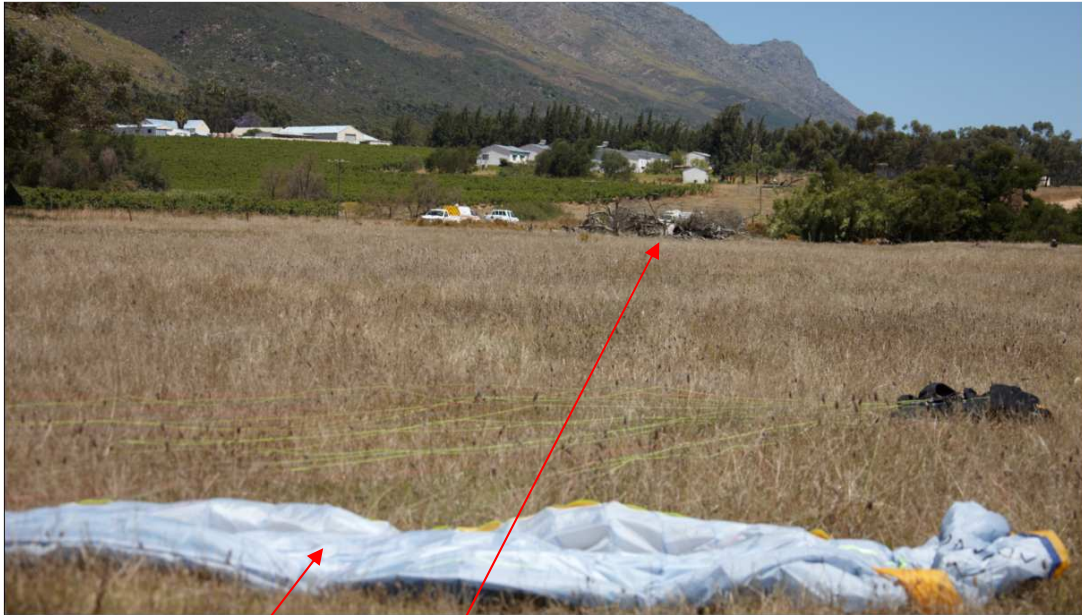
Glider& Harness (1) with body (2) behind bushes in the background

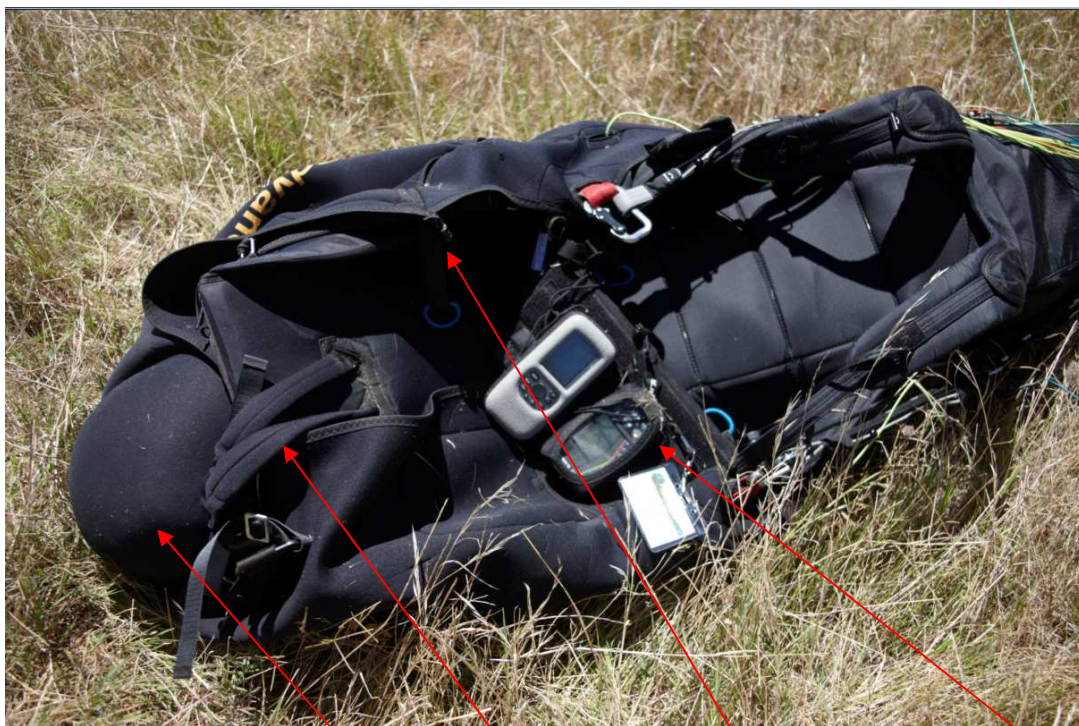
Harness showing Neoprene Skirt(1), leg straps(2), Skirt attachment (3) and Cockpit(4)

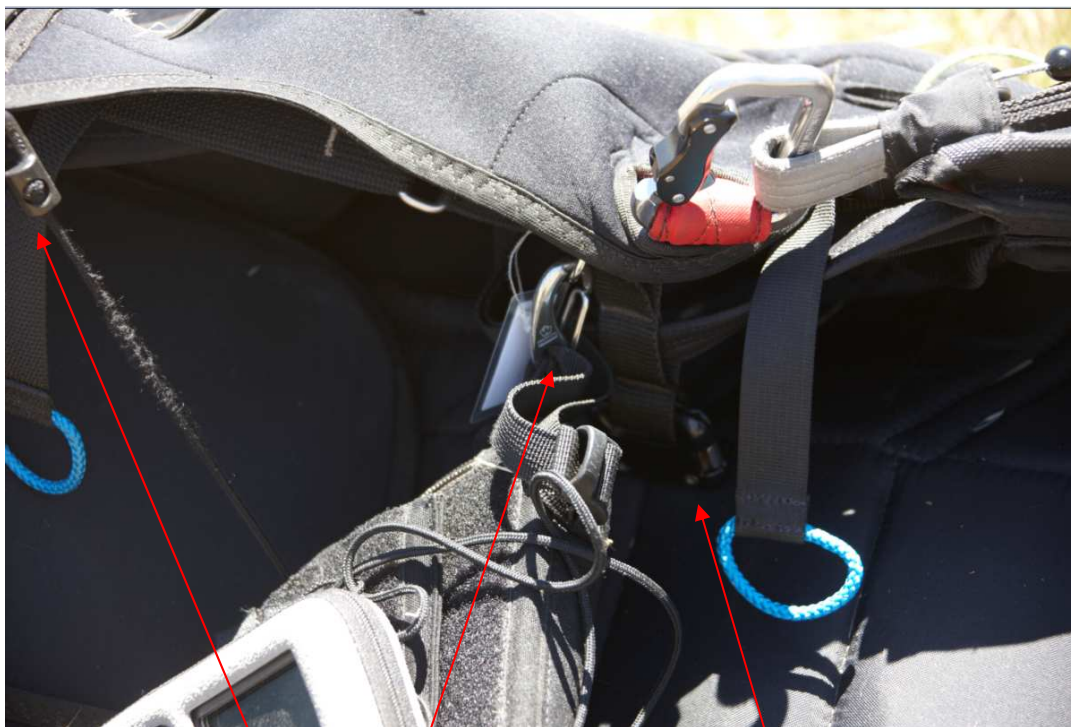
Close up view of the skirt (1) and cockpit(2) attachment indicating that they were done up.  
The one leg strap attachment is also visible(3)

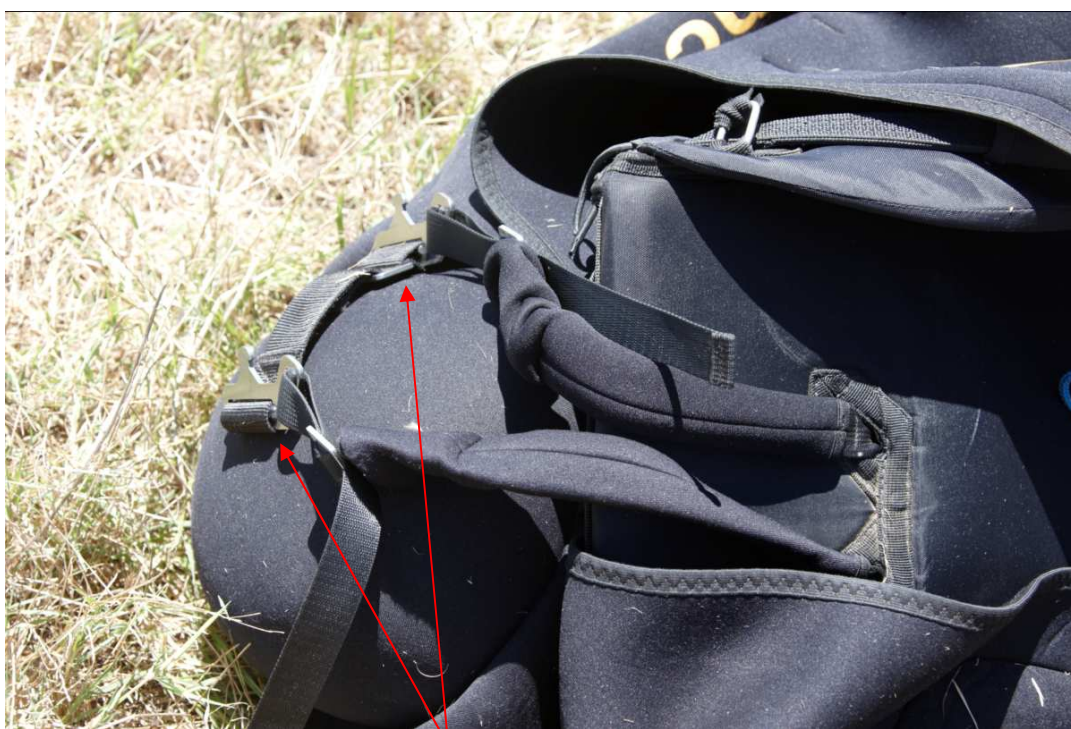
Leg strap buckles not done up

3.2.1 The pilot omitted to do up the main support straps on his harness.

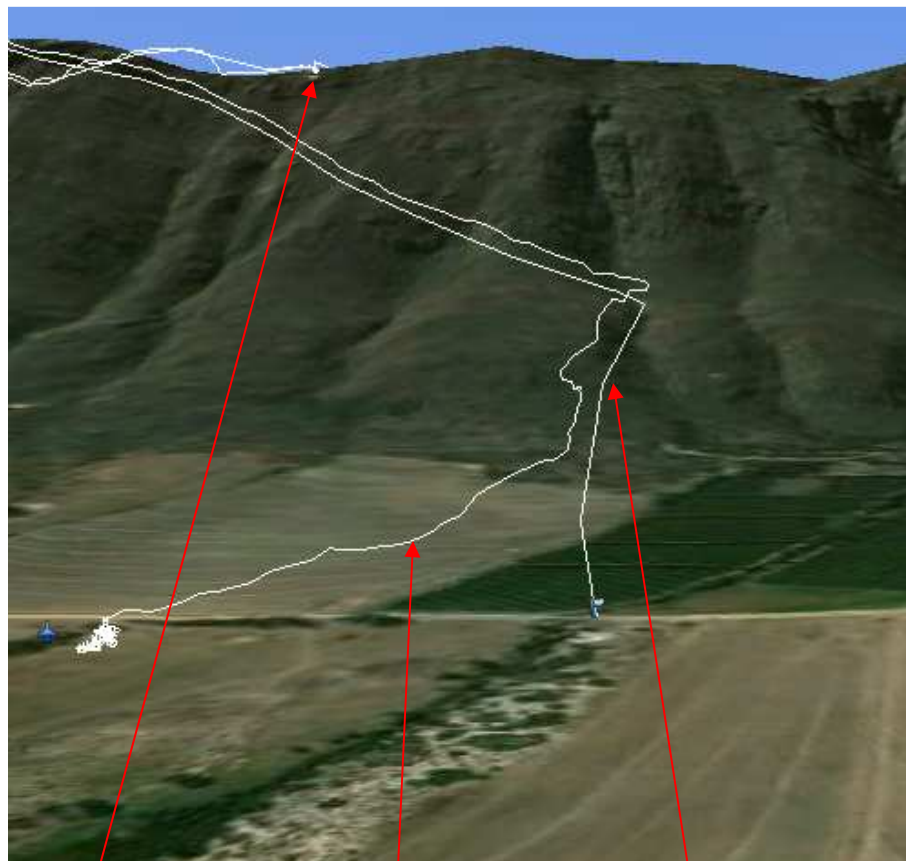
There are 2 tracks indicated, the one recorded by the Garmin GPS unit attached to the harness with a sampling rate of 2 seconds, and a second one recorded by the tracking device the pilot had on his person. There is a slight discrepancy in altitude between the two tracks as it used GPS altitude.

Launch Area

Glider Track

Pilot Track

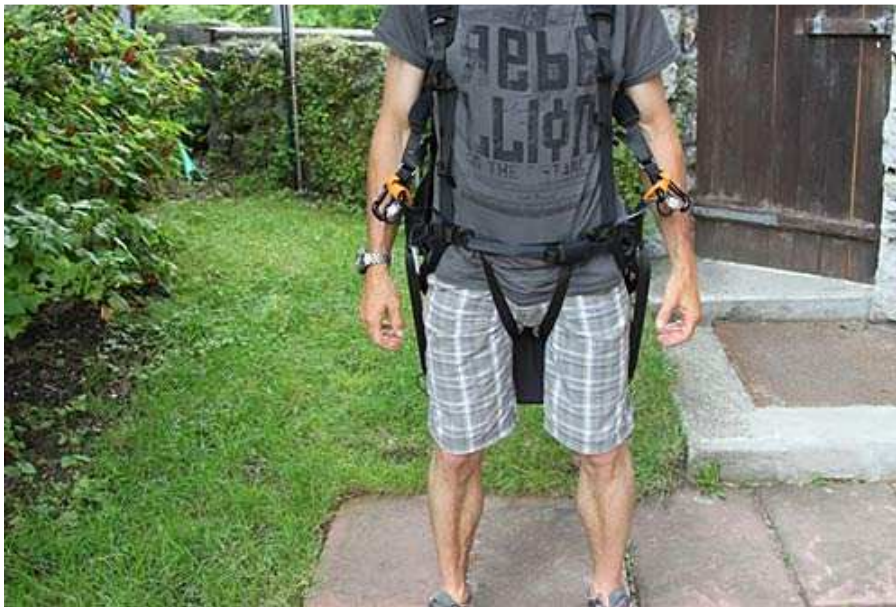
Picture 1: A common harness with Get-Up System correctly locked.

With common harnesses that incorporate the same restraining mechanism of the straps as the accident harness (a so called “Get-Up System”), a take off with open leg straps is not possible. First of all, the pilot would physically feel that the straps are not locked; second the launching paraglider would simply pull the harness up away from the pilot.

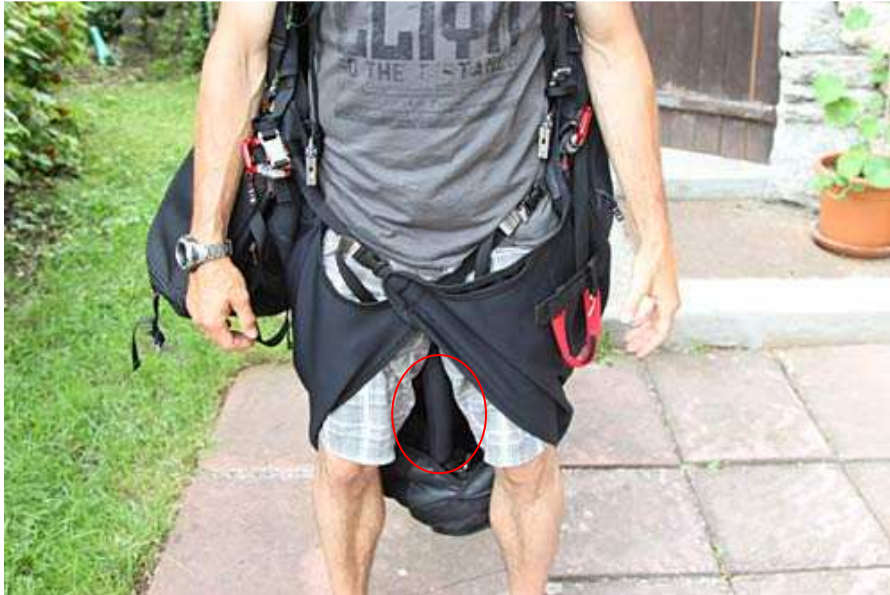
Picture 3: Genie Race with open latches but closed speed bag.

On the contrary, race harnesses like the Genie Race with closed speed bag and front container can mean the pilot feels locked into the harness even with leg and breast straps open. The pilot's view of the locking mechanism is almost completely blocked by the cockpit and the speed bag, and he is unable to see or feel if his latches are open or closed. It is also obscured to bystanders, so other pilots are unlikely to notice. The straps are not visibly hanging down between the legs, as with common harnesses (pic. 2) but they are hidden inside the speed bag.

The relatively tight neoprene speed bag gives the pilot a feeling of being closely connected with the harness, even with a completely open restraining mechanism. The pilot in the picture is an experienced XC pilot and was not able to feel whether his latches were open or closed.

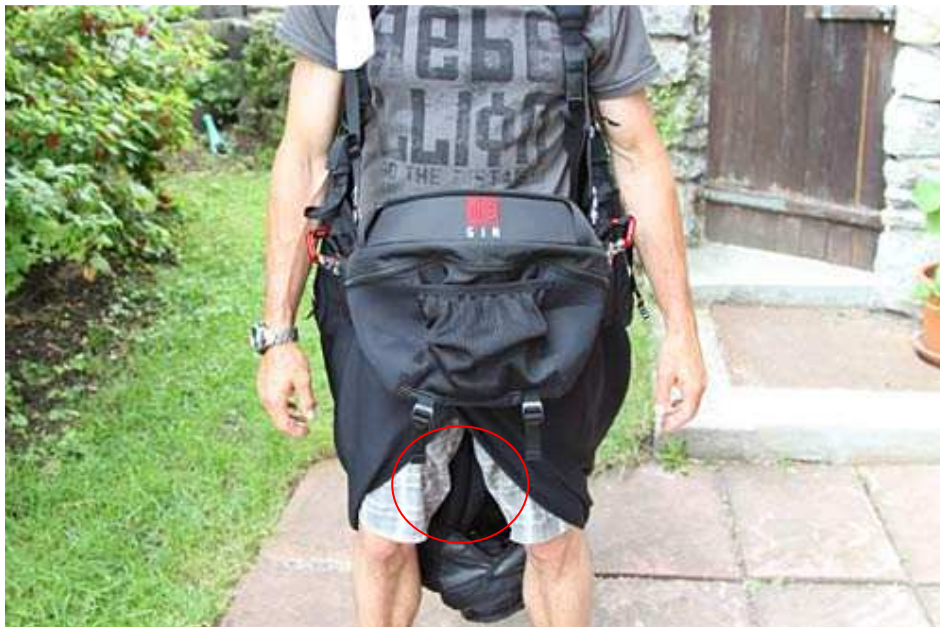
Picture 4: Genie Race with open straps but closed speed bag and locked in front-cockpit

The attached cockpit enhances the impression that everything is correctly locked in place, for both the pilot and for third parties that may check him over visually. The open restraining straps are barely visible inside the speed bag and are hard to notice.
