**PARAGLIDER ACCIDENT REPORT AND EXECUTIVE SUMMARY**

| | | | | Reference: | CA18/2/3/9123 | |
| <b>Aircraft Registration</b> | Not Applicable | <b>Date of Accident</b> | 10 January 2013 | | <b>Time of Accident</b> | 1221Z |
| <b>Type of Aircraft</b> | Paraglider | | <b>Type of Operation</b> | | Recreational | |

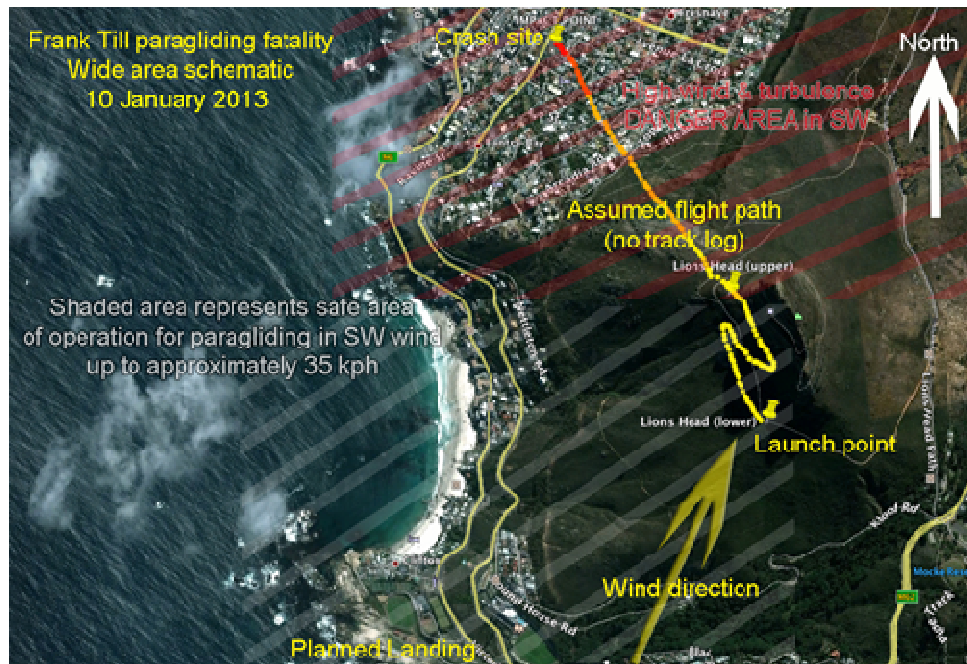
**Figure 5:** Wide area schematic

1.12.1 The pilot was most likely in a spiral dive before the point of impact, and it was evident that the canopy collided first with the fixed object (wall or banana tree) and then the wing snagged the wall close to the main entrance.

- 1.12.2 The paraglider crashed into a boundary wall of a residential home at the corner of Kloof Road and Alexandra Avenue, Fresnaye, Cape Town. The pilot's body was flung into the cast iron gate at the entrance to the property.
- 1.12.3 This impact was of such force it broke two welded bars from the decorative gate and bent the metal towards the house, away from the street.
- 1.12.4 The paraglider's canopy was found to the right on the sidewalk, marked with an unknown white powder.
- 1.12.5 The crash site location and impact points were within a 7 m radius.

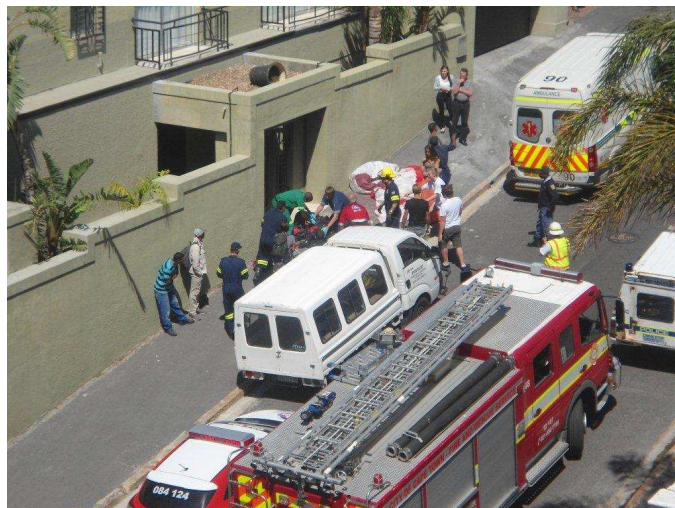
**Figure 7:** Emergency Services at the accident site

- 1.13.1 At approximately 1230Z emergency services were notified of the accident. They arrived shortly after the call to attend to the accident scene.
- 1.13.2 The emergency services staff found the pilot attached to the paraglider lying on the public sidewalk in respiratory trauma and not able to communicate.

- 1.13.3 First aid rendered on scene by paramedics and ambulance personnel could not prevent the person succumbing to compound trauma and respiratory difficulty. The pilot died on the scene at approximately 1245Z.
